Asbestos Reassessment

St. Luke
345 Albright Road, Hamilton,
Ontario

August 26, 2022

Pinchin File: 303992.004

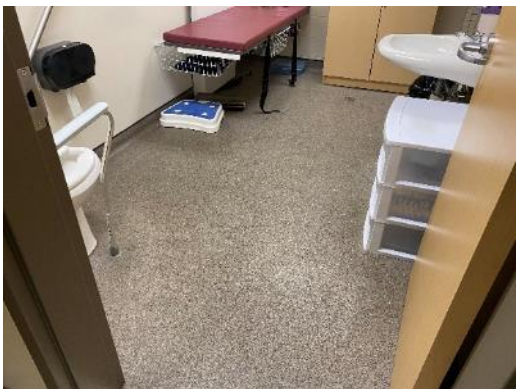
Material and Application	Asbestos Type/Friability	Photo
ceiling finishes.		
Asbestos in drywall joint compound was banned in Canada in 1980. Drywall joint compound in the 2005 addition was installed after 1986 (1980 plus a reasonable non-compliance period based on our experience) and is assumed to contain no asbestos.	None	
Vinyl sheet flooring, with grey with green and red flecks pattern is present.	Presumed/Potentially Friable

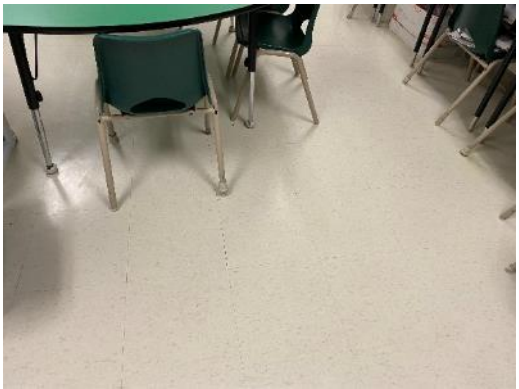
Vinyl floor tiles, 12"x12", white with grey flecks, are present	<0.5% Chrysotile (tile) None (mastic)

Remaining vinyl floor tiles were presumed to be non-asbestos based on historical knowledge of the date of installation. Mastic underneath the vinyl floor tiles is presumed to contain asbestos until sampling proves otherwise.	None (tile) Presumed/Non-friable (mastic)
