Asbestos Reassessment

St. Margaret Mary
25 Brentwood Drive, Hamilton,
Ontario

August 23, 2022

Pinchin File: 303992.004

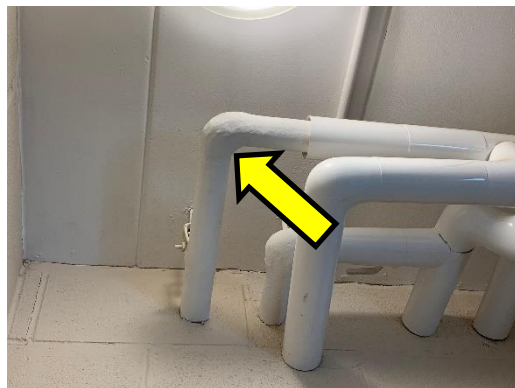
| Material and Application | Asbestos Type/Friability | Photo |
|---|---|--|
| Parging cement is present on pipe fittings (elbows, valves, tees, hangers etc.) | Chrysotile/Friable | |

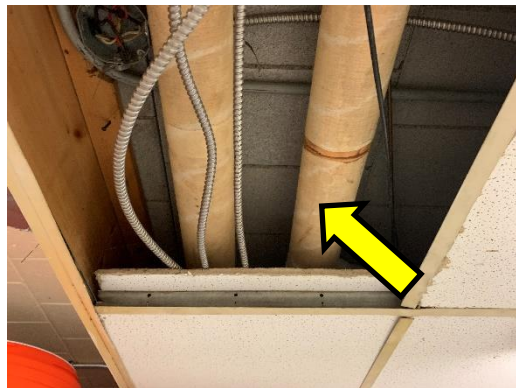
| Material and Application | Asbestos Type/Friability | Photo |
|---|---|--|
| A white corrugated paper insulation (trade name Aircell), is present on straight sections of pipes. | Chrysotile/Friable | |

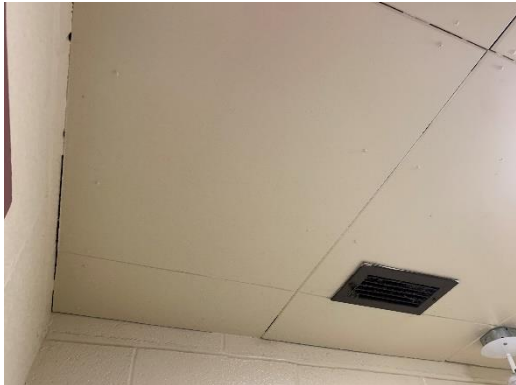
| Material and Application | Asbestos Type/Friability | Photo |
|---|---|--|
| Transite board is present as a ceiling finish. | Presumed/Non-friable | |

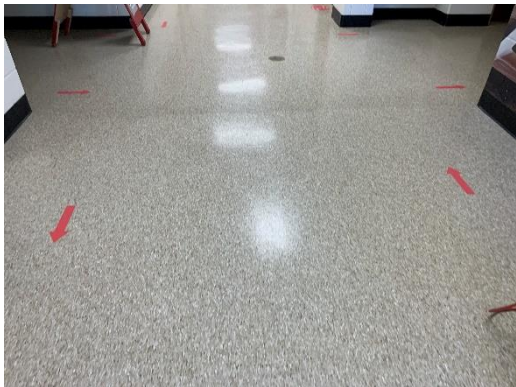
| Material and Application | Asbestos Type/Friability | Photo |
|--|--|--|
| Vinyl floor tiles, 12"x12", light grey multi-fleck, are present. | Presumed/Non-friable (tile) Presumed/Non-friable (mastic) | |

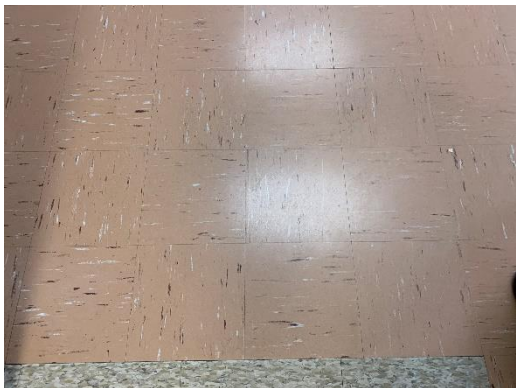
| Material and Application | Asbestos Type/Friability | Photo |
|--|--|--|
| Vinyl floor tiles, 9"x9", pink with white and brown streak, are present. | Presumed/Non-friable (tile) Presumed/Non-friable (mastic) | |

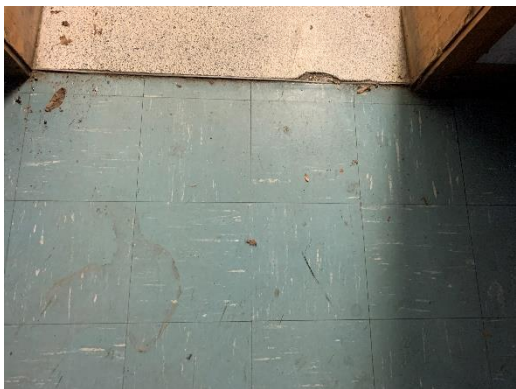
| Material and Application | Asbestos Type/Friability | Photo |
|--|--|--|
| Vinyl floor tiles, 9"x9", green with white streaks, are present. | Presumed/Non-friable (tile) Presumed/Non-friable (mastic) | |

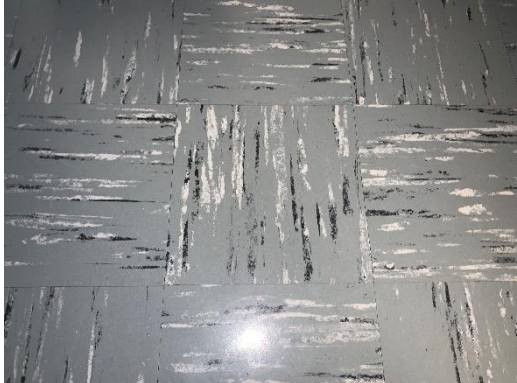
| Material and Application | Asbestos Type/Friability | Photo |
|--|--|--|
| Vinyl floor tiles, 9"x9", grey with white and black streaks, are present. | Presumed/Non-friable (tile) Presumed/Non-friable (mastic) | |

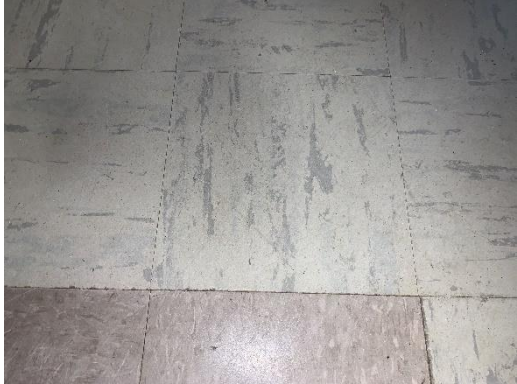
| Material and Application | Asbestos Type/Friability | Photo |
|--|--|--|
| Vinyl floor tiles, 9"x9", white with grey streaks, are present. | Presumed/Non-friable (tile) Presumed/Non-friable (mastic) | |

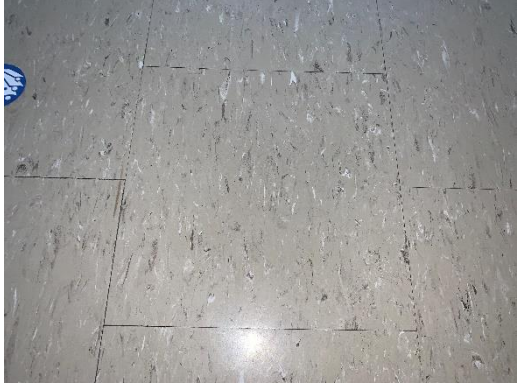
| Material and Application | Asbestos Type/Friability | Photo |
|--|--|--|
| Vinyl floor tiles, 12"x12", brown with white and black streaks, are present. | Presumed/Non-friable (tile) Presumed/Non-friable (mastic) | |

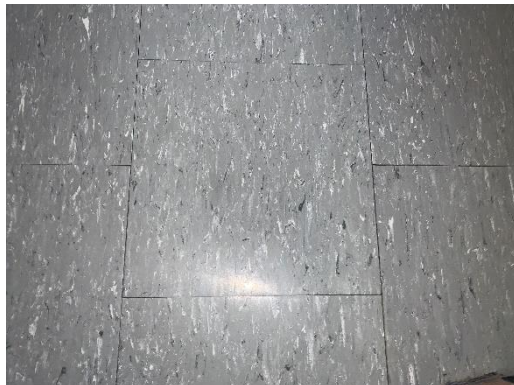
| Material and Application | Asbestos Type/Friability | Photo |
|---|--|---|
| Vinyl floor tiles, 12"x12", grey with white and black streaks, are present. | Presumed/Non-friable (tile) Presumed/Non-friable (mastic) | |

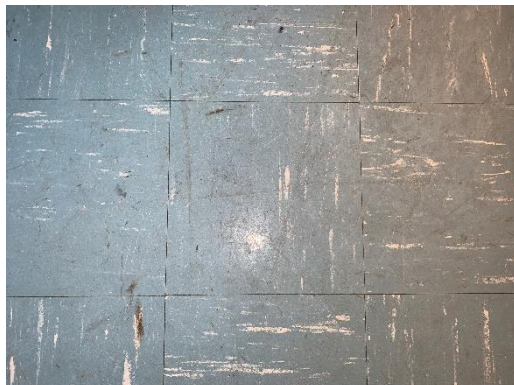
| Material and Application | Asbestos Type/Friability | Photo |
|---|--|---|
| Vinyl floor tiles, 9"x9", blue with white streaks, are present. | Presumed/Non-friable (tile) Presumed/Non-friable (mastic) | |

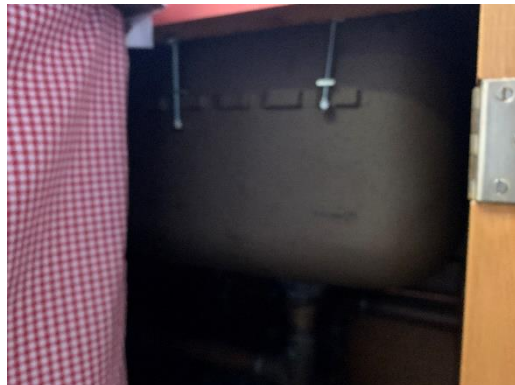
| Material and Application | Asbestos Type/Friability | Photo |
|--|---|--|
| Gold mastic is present as a sink undercoating. | Presumed/Non-friable | |
