Asbestos Reassessment

St. Martin of Tours
60 Grays Road, Stoney Creek,
Ontario

August 12, 2022

Pinchin File: 303992.004

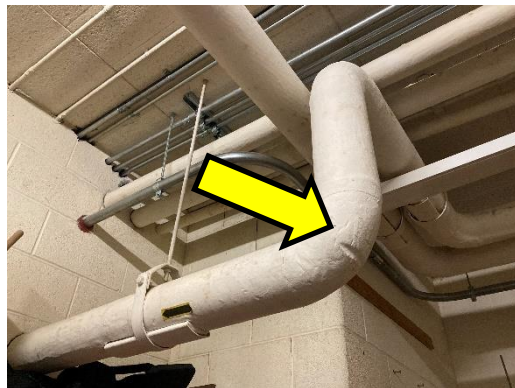
Material and Application	Asbestos Type/Friability	Photo
Parging cement is present on pipe fittings (elbows, valves, tees, hangers etc.)	Chrysotile/Friable

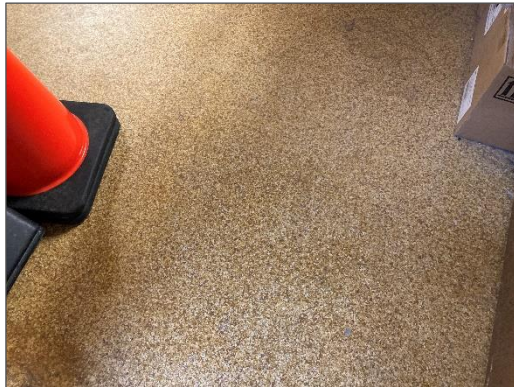
Material and Application	Asbestos Type/Friability	Photo
uninsulated or insulated with non-asbestos fibreglass.		
All ceiling tiles are presumed to be non-asbestos based on the date of manufacture determined from the date stamp applied to the top of the tiles or the age of the materials determined from the age of the building renovation.	None	
Textured plaster present on walls and ceilings does not contain asbestos.	None	
Rough plaster present on the structure does not contain asbestos.	None	
Vinyl sheet flooring, with a brown speckled pattern, is present.	None (flooring) Presumed/Non-friable (mastic)

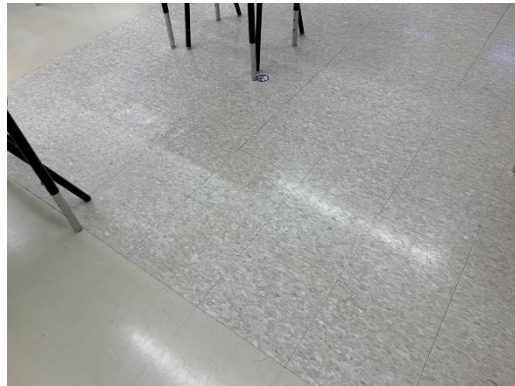
Material and Application	Asbestos Type/Friability	Photo
Vinyl floor tiles, 12"x12" beige with dark streak are present.	Chrysotile/Non-friable (tile) Chrysotile/Non-friable (mastic)	 
Vinyl floor tiles, 12"x12" grey oatmeal are present.	Presumed/Non-friable (tile) Presumed/Non-friable (mastic)

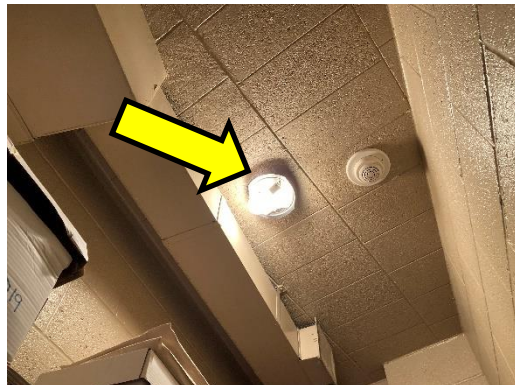
Material and Application	Asbestos Type/Friability	Photo
Paper heat shields are present.	Presumed/Non-Friable
