Asbestos Reassessment

St. Mary Catholic Education
Resource Centre
209 MacNab Street North,
Hamilton, Ontario

August 30, 2022

Pinchin File: 303992.004

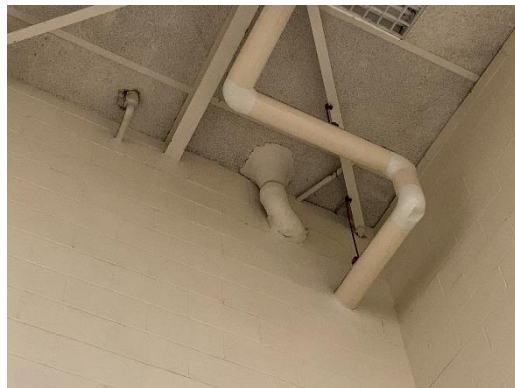
Material and Application	Asbestos Type/Friability	Photo
Parging cement is present on pipe fittings (elbows, valves, tees, hangers etc.)	Chrysotile/Friable

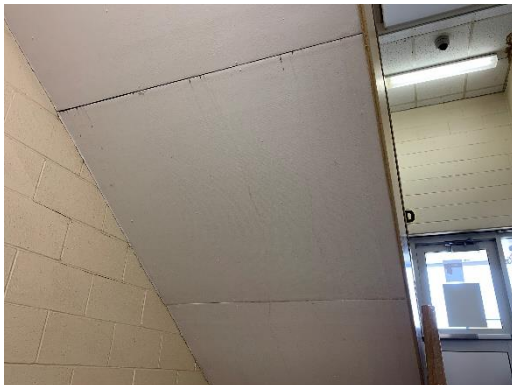
Material and Application	Asbestos Type/Friability	Photo
Mechanical equipment is either uninsulated or insulated with non-asbestos fibreglass.	None	
All ceiling tiles were determined to be non-asbestos by sample analysis or are presumed to be non-asbestos based on the date of manufacture determined from the date stamp applied to the top of the tiles, the age of the materials determined from the age of the building renovation, or based on the nature of the materials.	None	
Non-asbestos drywall joint compound is present on wall and ceiling finishes.	None	
Transite board is present underneath stairs.	Presumed/Non-friable

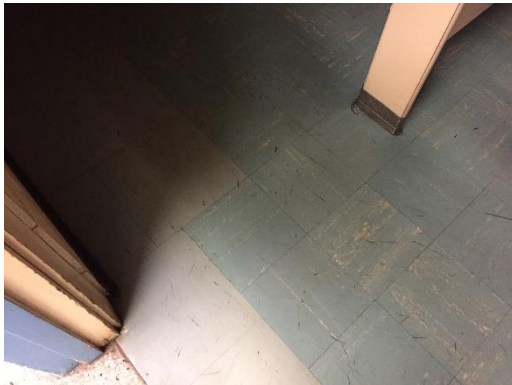
Vinyl floor tiles, 9"x9", teal with white streaks, are present.	Chrysotile/Non-friable (tile) Presumed/Non-friable (mastic)

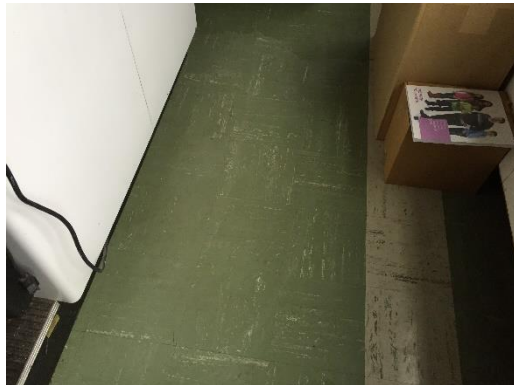
Material and Application	Asbestos Type/Friability	Photo
	Presumed/Non-friable (mastic)	
Vinyl floor tiles, 9"x9", green with white streaks, are present.	Chrysotile/Non-friable (tile) Presumed/Non-friable (mastic)

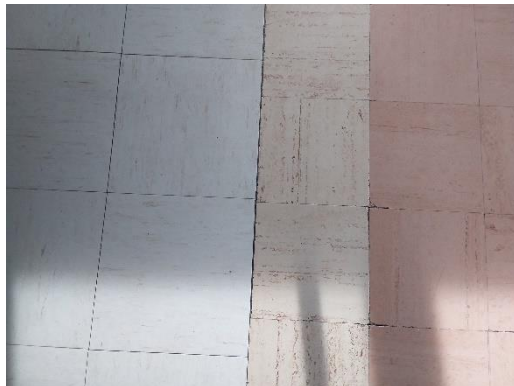
Vinyl floor tiles, 9"x9", cream with orange streaks, are present.	Chrysotile/Non-friable (tile) Presumed/Non-friable (mastic)

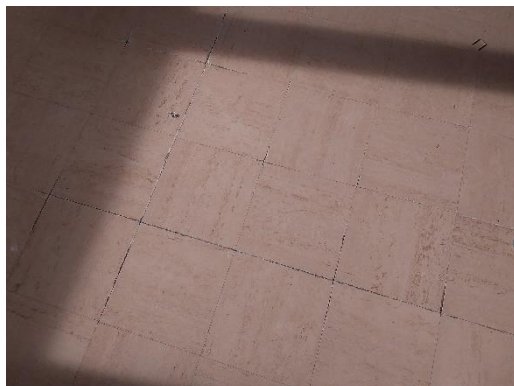
Vinyl floor tiles, 9"x9", cream with green streaks, are present.	Chrysotile/Non-friable (tile) Presumed/Non-friable (mastic)	
Vinyl floor tiles, 9"x9", orange, are present.	Chrysotile/Non-friable (tile) Presumed/Non-friable (mastic)

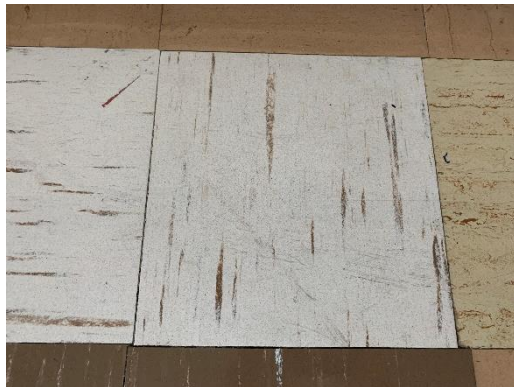
Material and Application	Asbestos Type/Friability	Photo
Vinyl floor tiles, 9"x9", white with grey streaks, are present.	Chrysotile/Non-friable (tile) Presumed/Non-friable (mastic)

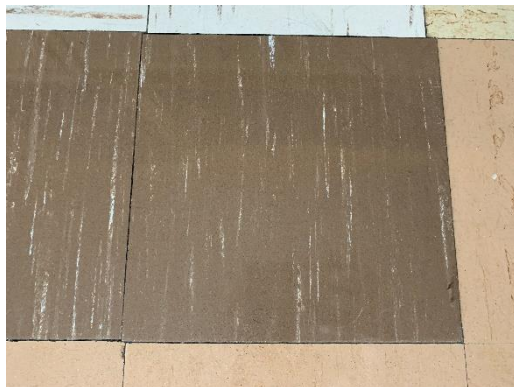
Vinyl floor tiles, 9"x9", brown with white streaks, are present.	Chrysotile/Non-friable (tile) Presumed/Non-friable (mastic)
