Asbestos Reassessment

St. Michael
135 Hester Street, Hamilton,
Ontario

**Hamilton-Wentworth Catholic
District School Board**

August 30, 2022

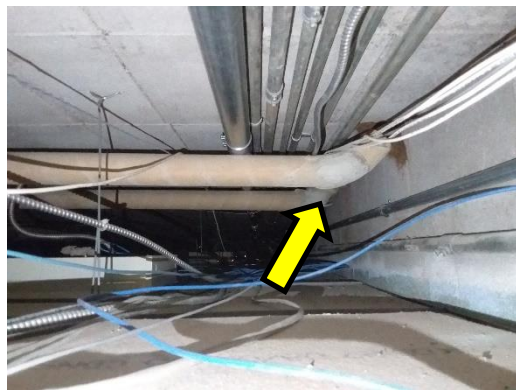
| Material and Application | Asbestos Type/Friability | Photo |
|---|---|--|
| Parging cement is present on pipe fittings (elbows, valves, tees, hangers etc.) | Chrysotile/Friable | |

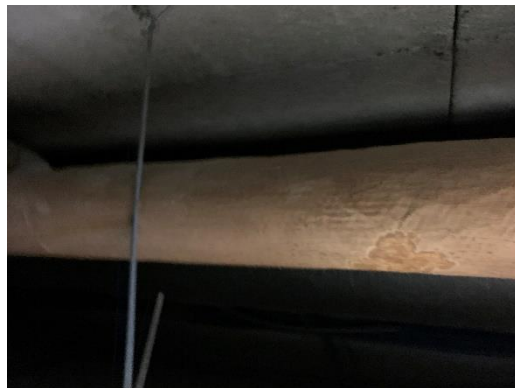
| Material and Application | Asbestos Type/Friability | Photo |
|---|---|--|
| Sweatwrap insulation (brown layered paper), is present on straight sections of pipes. | None | |

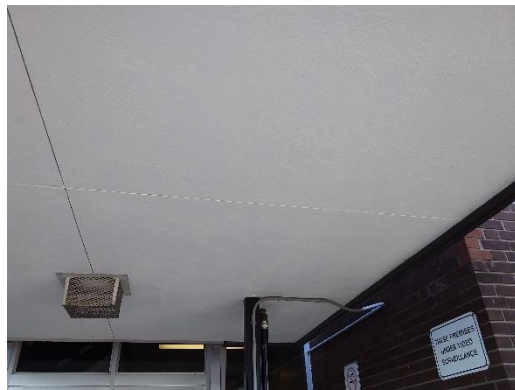
| Material and Application | Asbestos Type/Friability | Photo |
|--|---|--|
| Textured plaster is present as a soffit finish. | Chrysotile/Potentially Friable | |

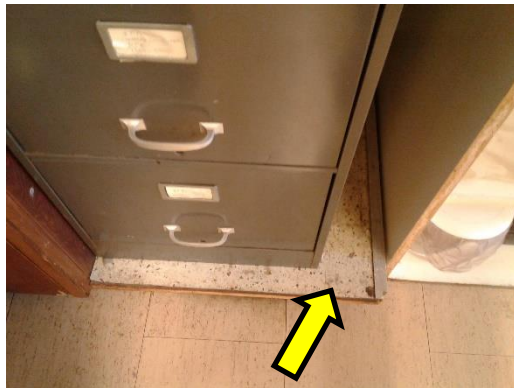
| Material and Application | Asbestos Type/Friability | Photo |
|---|--|--|
| Vinyl sheet flooring, with an off-white with dark flecks pattern is present. | Presumed/Potentially Friable | |

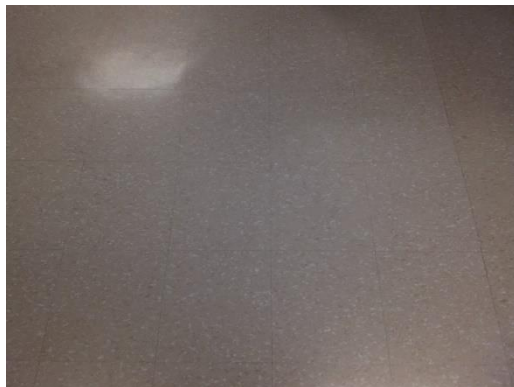
| Material and Application | Asbestos Type/Friability | Photo |
|---|--|--|
| Vinyl floor tiles, 12"x12", beige with white fleck, are present. | Presumed/Non-friable (tile) Presumed/Non-friable (mastic) | |

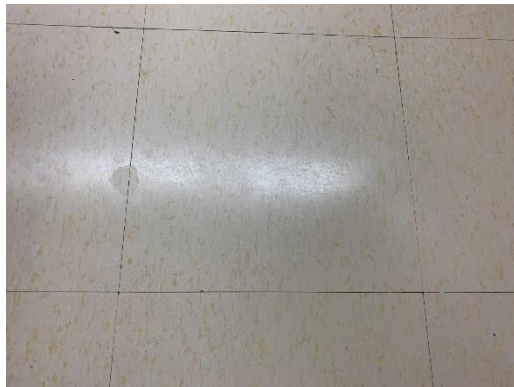
| Material and Application | Asbestos Type/Friability | Photo |
|--|--|--|
| Vinyl floor tiles, 12"x12", beige with orange fleck, are present. | Presumed/Non-friable (tile) Presumed/Non-friable (mastic) | |

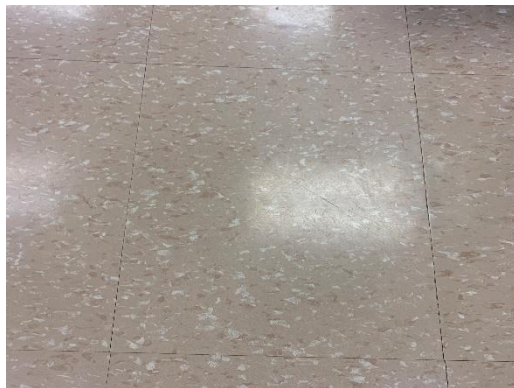
| Material and Application | Asbestos Type/Friability | Photo |
|--|--|--|
| Vinyl floor tiles, 12"x12", salmon with white fleck, are present. | Presumed/Non-friable (tile) Presumed/Non-friable (mastic) | |

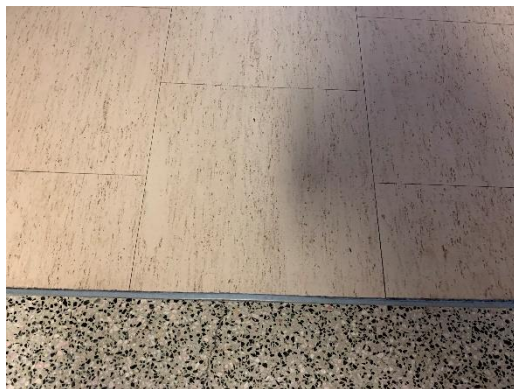
| Material and Application | Asbestos Type/Friability | Photo |
|--|--|--|
| Vinyl floor tiles, 12"x12", salmon with brown streak, are present. | Presumed/Non-friable (tile) Presumed/Non-friable (mastic) | |

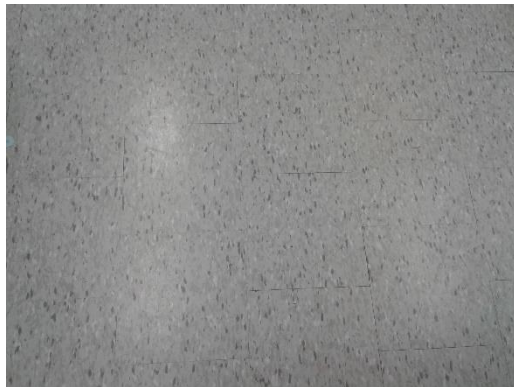
| Material and Application | Asbestos Type/Friability | Photo |
|---|--|--|
| Vinyl floor tiles, 12"x12", grey dense flecks, are present. | Presumed/Non-friable (tile) Presumed/Non-friable (mastic) | |

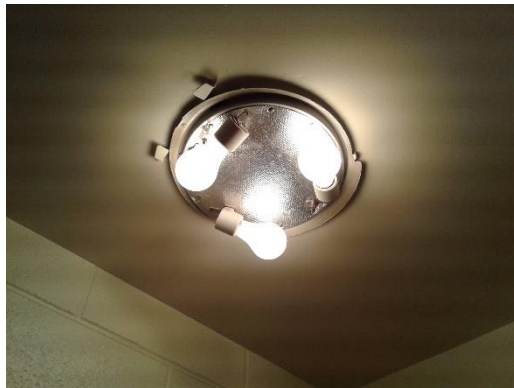
| Material and Application | Asbestos Type/Friability | Photo |
|---|--|--|
| Paper heat shields are present. | Presumed/Non-friable | |

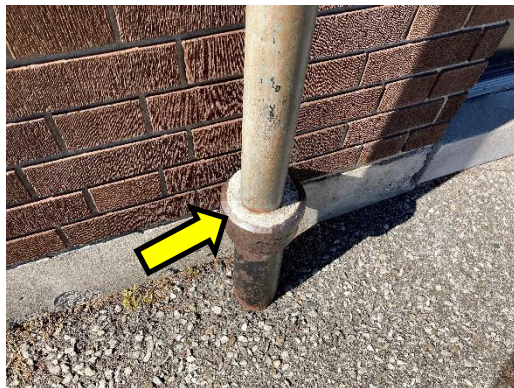
| Material and Application | Asbestos Type/Friability | Photo |
|---|--|--|
| Packing is present in an exterior bell and spigot fitting. | Amosite and Chrysotile/Potentially friable | |

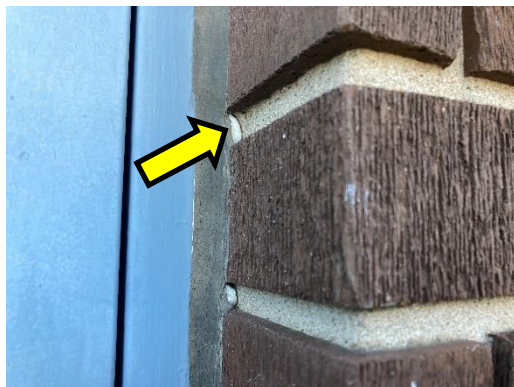
| Material and Application | Asbestos Type/Friability | Photo |
|---|--|--|
| White caulking is present around an exterior door | Chrysotile/Non-friable | |
