Asbestos Reassessment

St. Patrick
24 Smith Avenue, Hamilton,
Ontario

Pinchin File: 303992.004

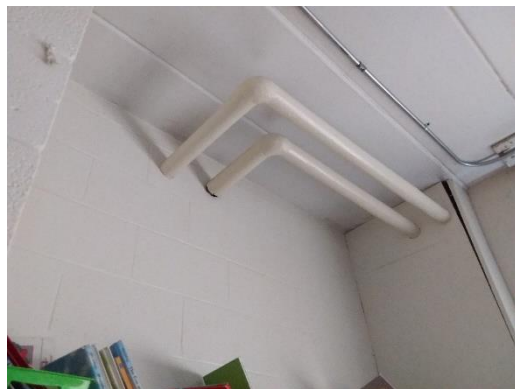
Material and Application	Asbestos Type/Friability	Photo
Parging cement is present on pipe fittings (elbows, valves, tees, hangers etc.)	Chrysotile/Friable

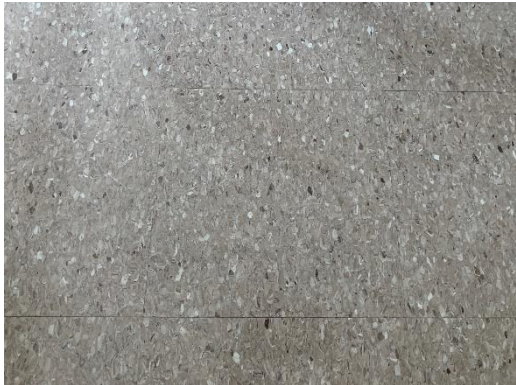
Material and Application	Asbestos Type/Friability	Photo
Vinyl floor tiles, 12"x12", grey multi-fleck, are present.	Presumed/Non-friable (tile) Presumed/Non-friable (mastic)

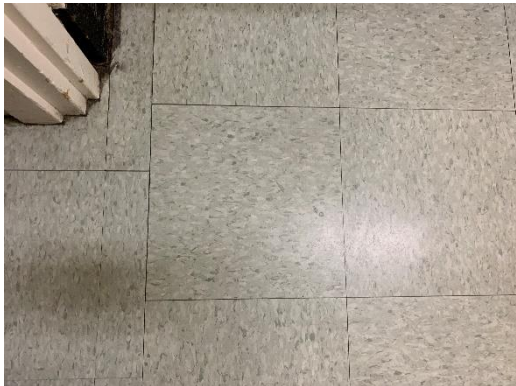
Vinyl floor tiles, 12"x12", light grey multi-fleck, are present.	Presumed/Non-friable (tile) Presumed/Non-friable (mastic)

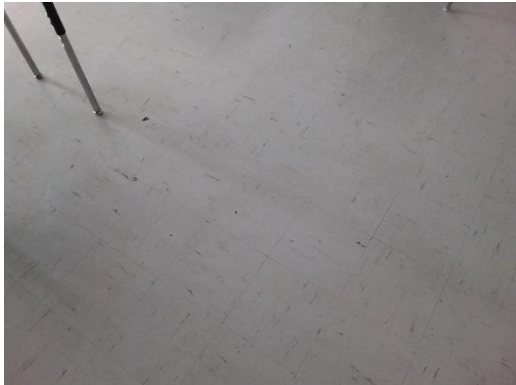
Vinyl floor tiles, 12"x12", white with multi-coloured streaks, are present.	Presumed/Non-friable (tile) Presumed/Non-friable (mastic)

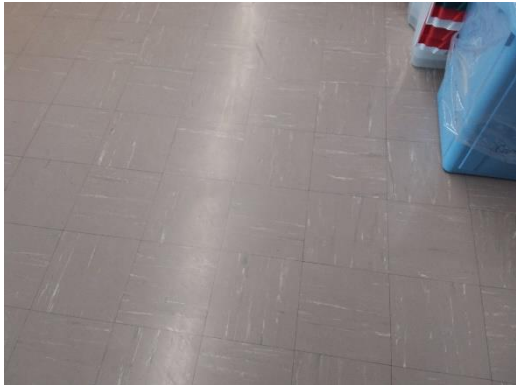
Material and Application	Asbestos Type/Friability	Photo
Vinyl floor tiles, 9"x9" beige with white streaks are present.	Presumed/Non-friable (tile) Presumed/Non-friable (mastic)

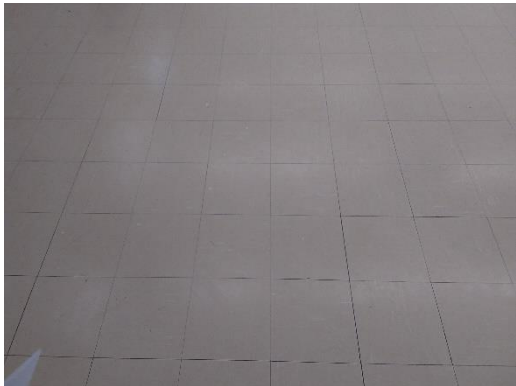
Vinyl floor tiles, 9"x9" green with white are present.	Presumed/Non-friable (tile) Presumed/Non-friable (mastic)

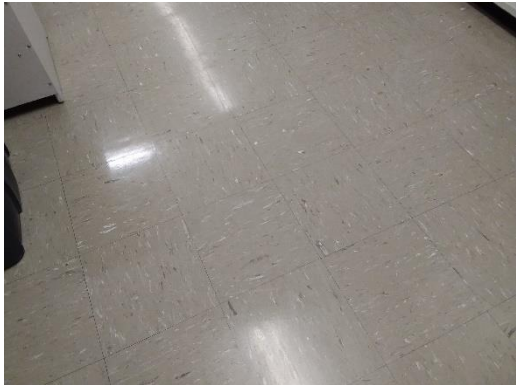
Vinyl floor tiles, 9"x9" brown with white brush are present.	Presumed/Non-friable (tile) Presumed/Non-friable (mastic)

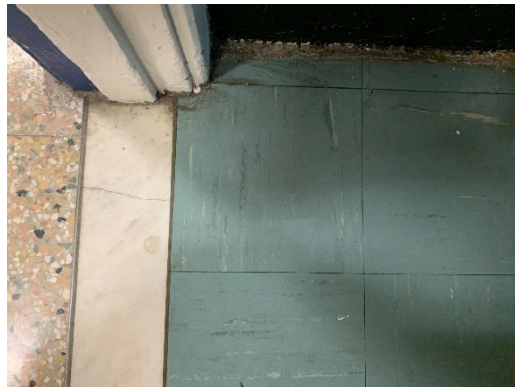
Material and Application	Asbestos Type/Friability	Photo
Vinyl floor tiles, 9"x9" green with white brush are present.	Presumed/Non-friable (tile) Presumed/Non-friable (mastic)
