# Asbestos Reassessment

St. Paul  
24 Amberwood Street, Stoney  
Creek, Ontario

**Hamilton-Wentworth Catholic  
District School Board**

August 26, 2022

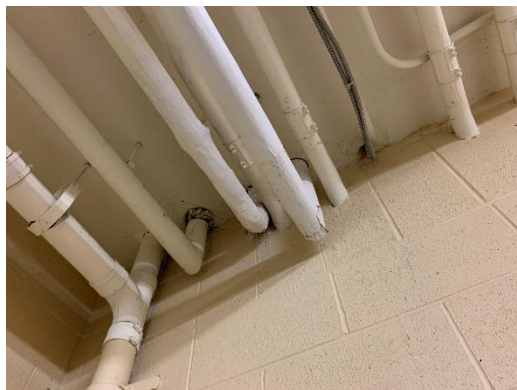
Material and Application	Asbestos Type/Friability	Photo
Parging cement is non-asbestos based on the date of construction of the building (1985).	None	
Remaining pipes are either uninsulated or insulated with non-asbestos fibreglass or elastomeric insulation (Armaflex).	None

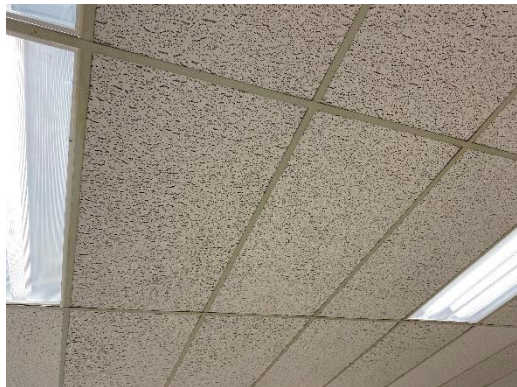
Material and Application	Asbestos Type/Friability	Photo
24"x48" lay-in ceiling tiles, with a long fissure and random pinhole pattern are present.	None

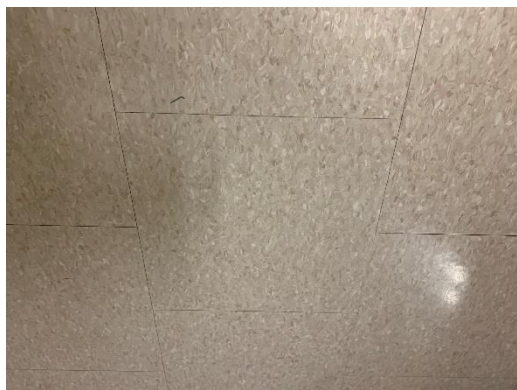
24"x48" lay-in ceiling tiles, with a pinhole and fleck pattern are present.	None	
Non-asbestos drywall joint compound is present on wall and ceiling finishes.	None	
Vinyl floor tiles, 12"x12" light pink marble, are present.	Presumed/Non-friable (tile) Presumed/Non-friable (mastic)

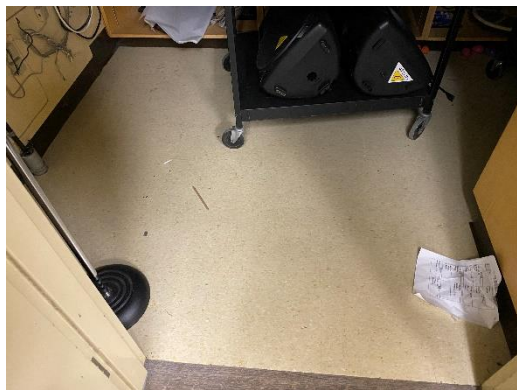
Vinyl floor tiles, 12"x12" orange cream multi-fleck, are present.	Presumed/Non-friable (tile) Presumed/Non-friable (mastic)

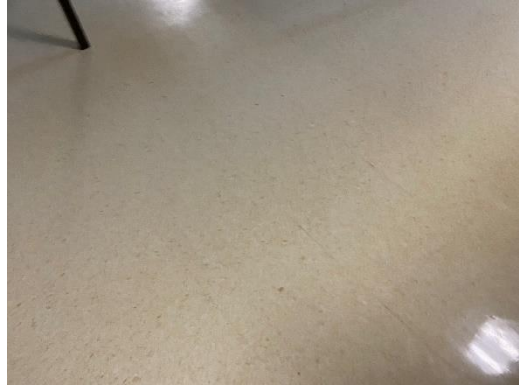
Material and Application	Asbestos Type/Friability	Photo
Vinyl floor tiles, 12"x12" light grey with specks, are present.	Presumed/Non-friable (tile)  Presumed/Non-friable (mastic)

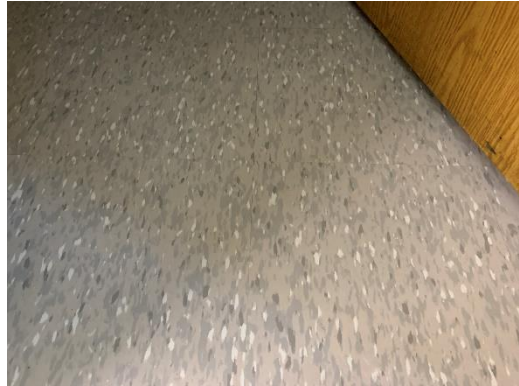
Vinyl floor tiles, 12"x12" light blue with grey specks, are present.	Presumed/Non-friable (tile)  Presumed/Non-friable (mastic)

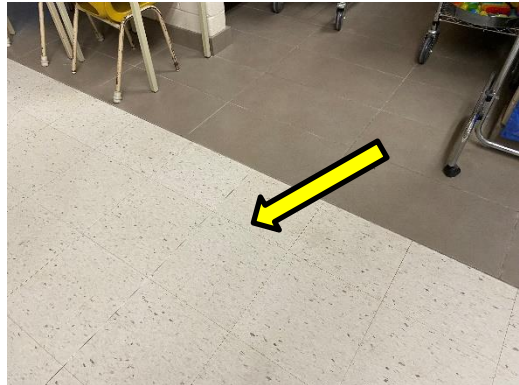
Vinyl floor tiles, 12"x12" white with blue fleck, are present.	Presumed/Non-friable (tile)  Presumed/Non-friable (mastic)
