Asbestos Reassessment

St. Teresa of Avila
171 San Remo Drive, Hamilton,
Ontario

**Hamilton-Wentworth Catholic
District School Board**

August 29, 2022

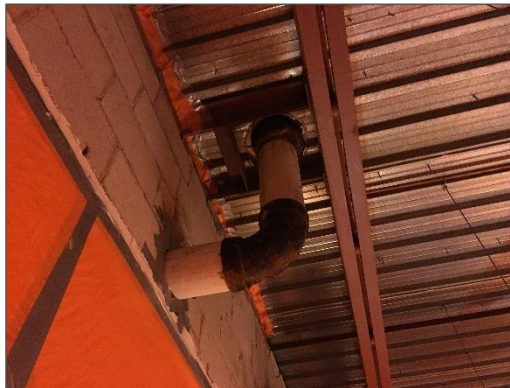
| Material and Application | Asbestos Type/Friability | Photo |
|--|---|--|
| Transite pipe is present as a rainwater leader in the Girl's Washroom (Location 123) | Presumed/Non-friable | |

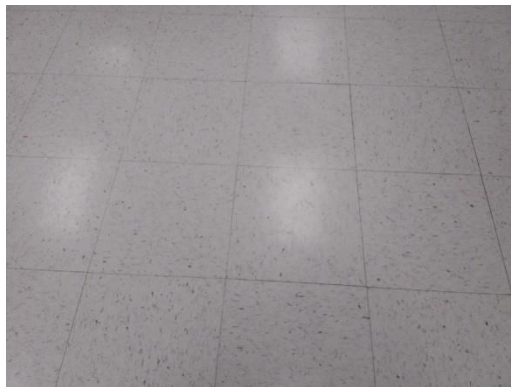
| Material and Application | Asbestos Type/Friability | Photo |
|--|---|--|
| Vinyl floor tiles and mastic were determined to be non-asbestos by sample analysis or were presumed to be non-asbestos based on historical knowledge of the date of installation. | None (tile) None (mastic) | |

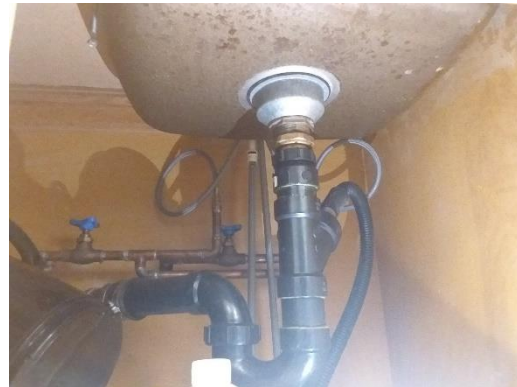
| Material and Application | Asbestos Type/Friability | Photo |
|--|---|--|
| Gold mastic is present as a sink undercoating. | Presumed/Non-friable | |
