Asbestos Reassessment

St. Vincent de Paul
295 Greencedar Drive, Hamilton,
Ontario

August 29, 2022

Pinchin File: 303992.004

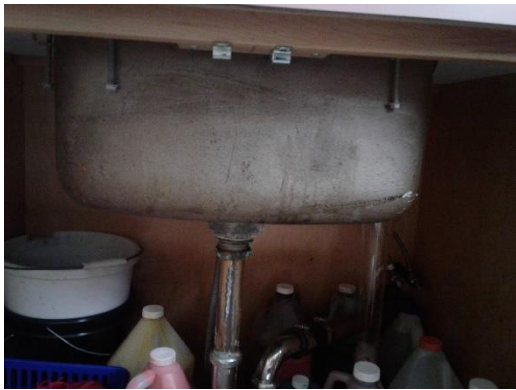
Material and Application	Asbestos Type/Friability	Photo
Gold mastic is present as a sink undercoating.	Chrysotile/Non-friable

Remove asbestos-containing materials (ACM) prior to alteration or maintenance work if ACM may be disturbed by the work. Follow appropriate asbestos precautions for the classification of work being performed.

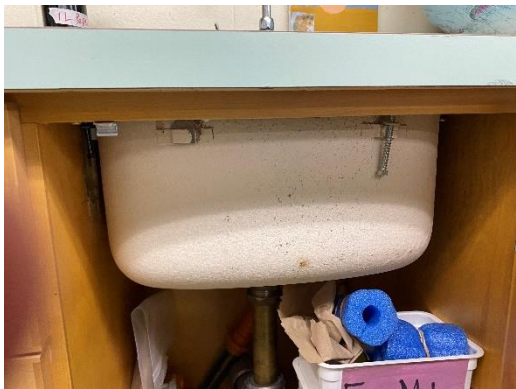
White sink undercoating does not contain asbestos.	None

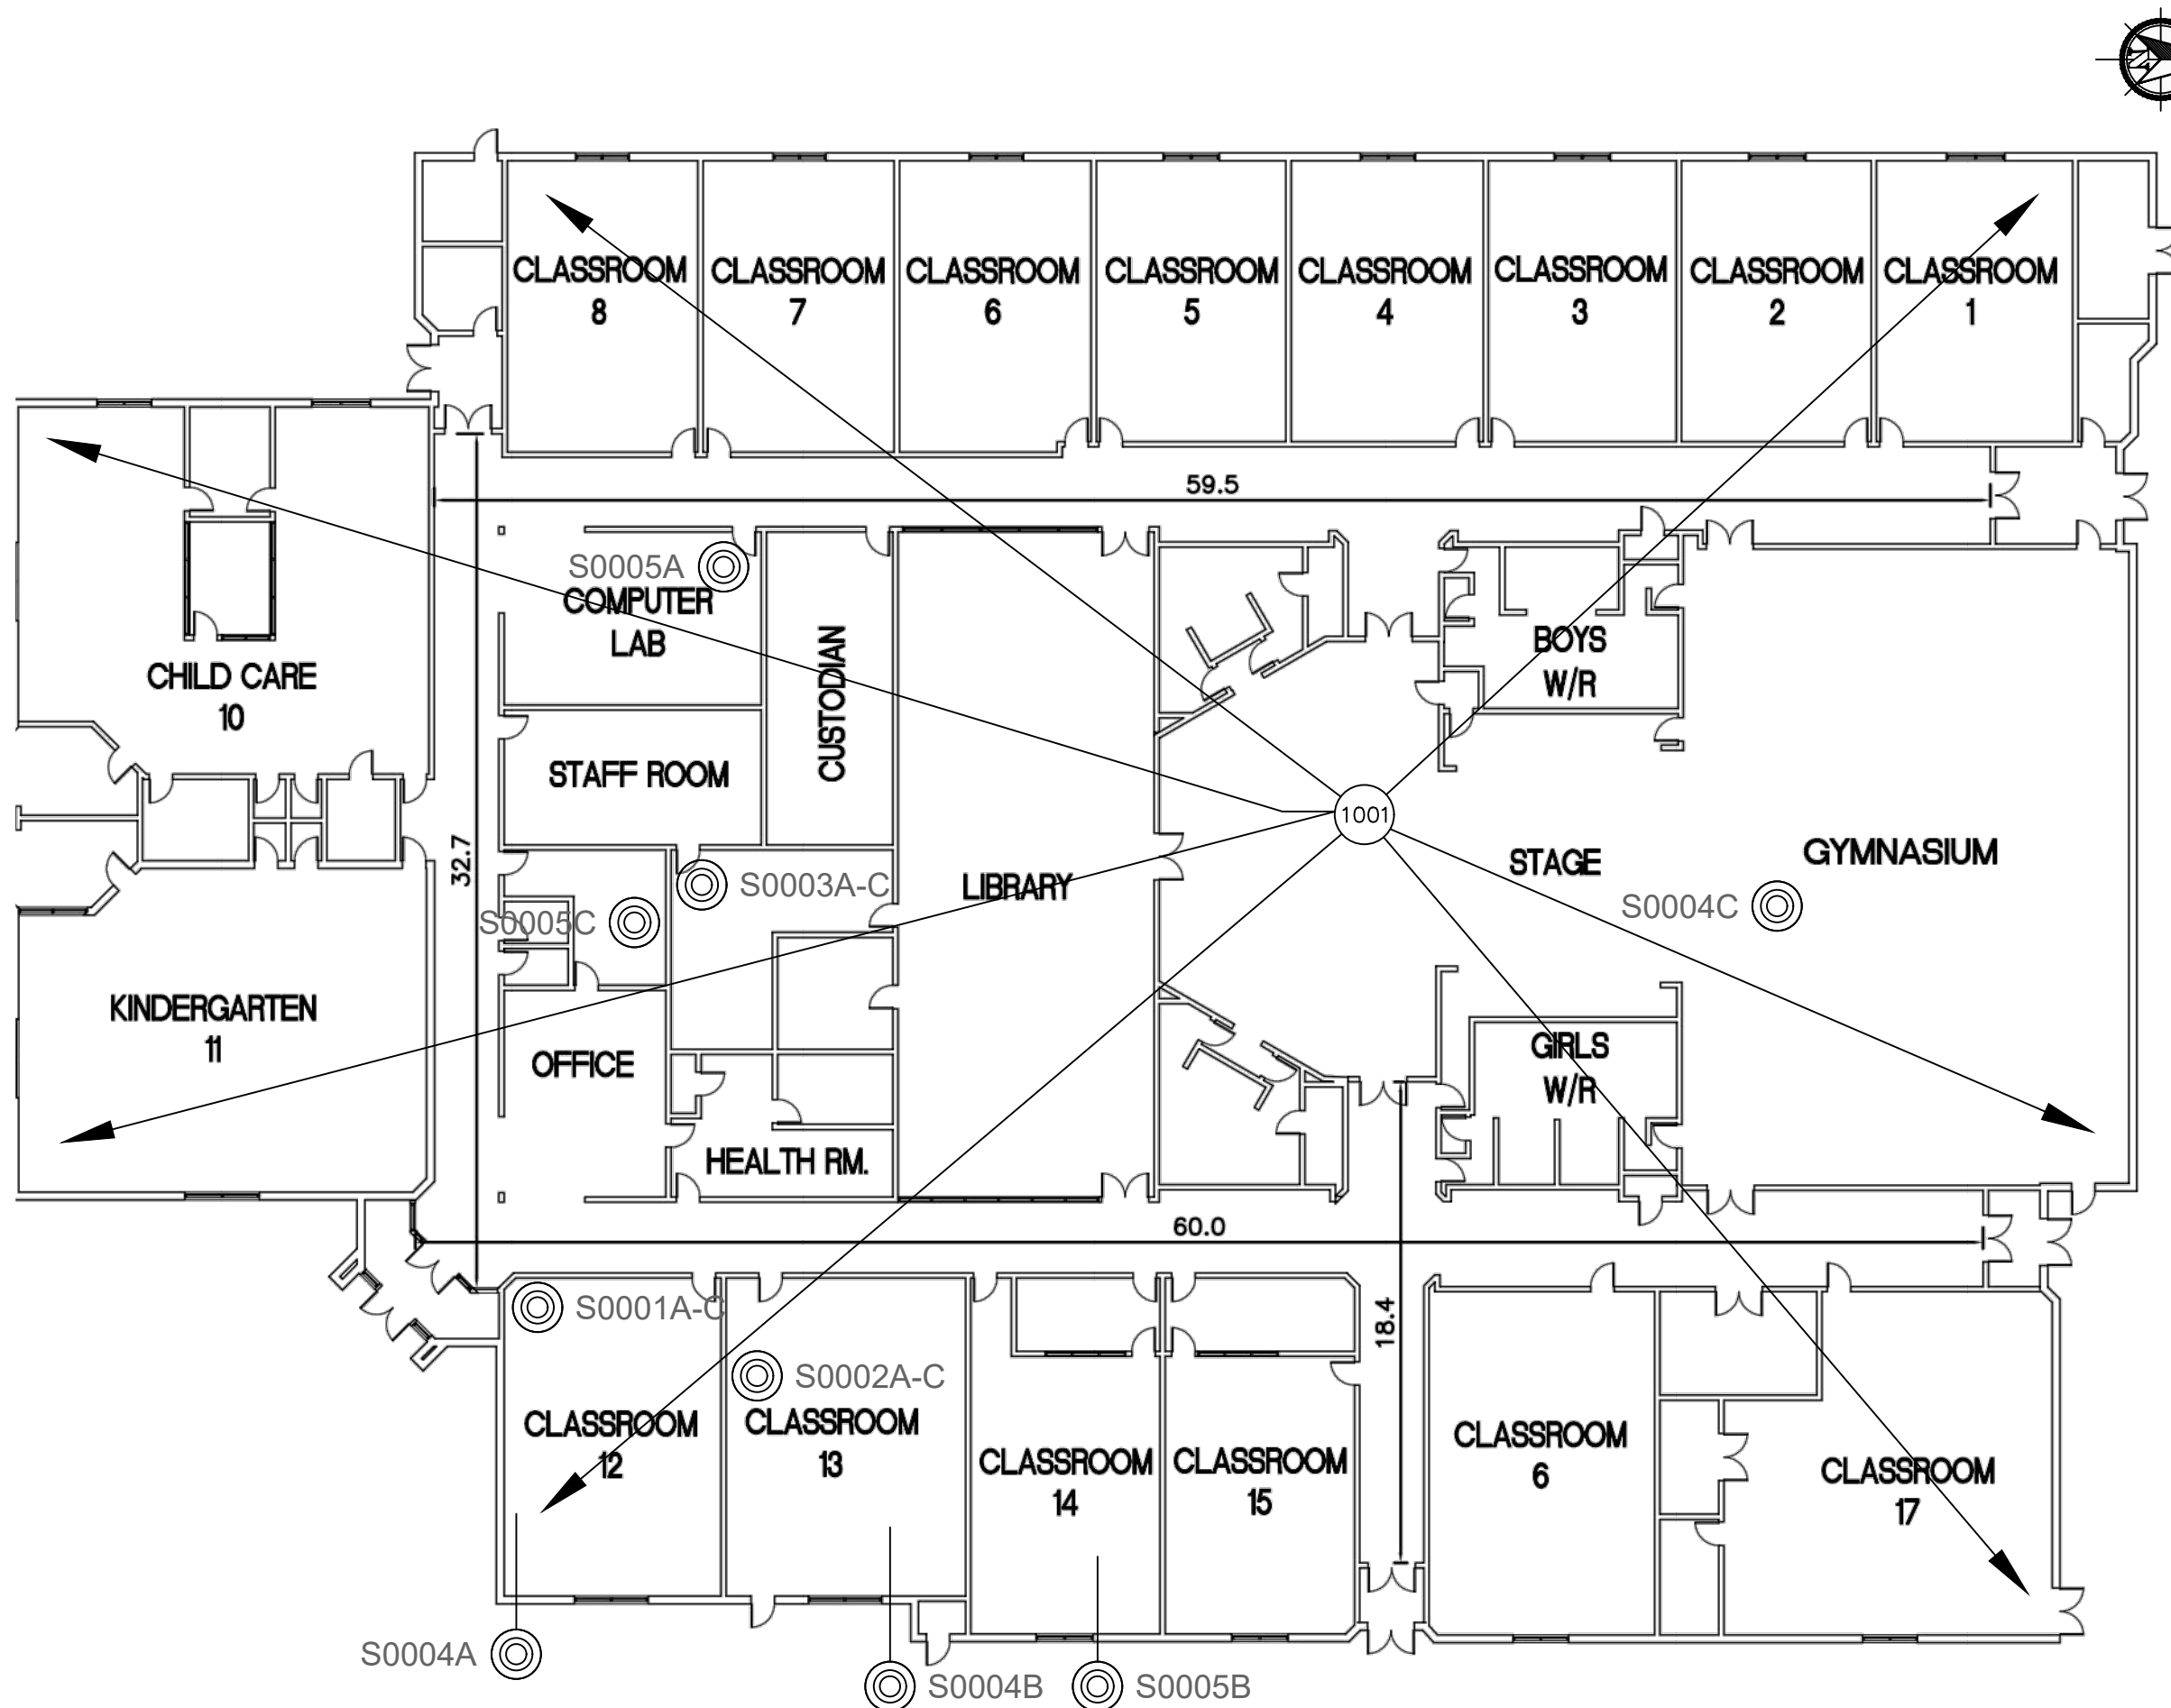
ASBESTOS REASSESSMENT
FLOOR LEVEL 1

ASBESTOS-CONTAINING GOLD MASTIC UNDERCOATING IS PRESENT SPORADICALLY ON SINKS WITHIN THE BUILDING.
