Asbestos Reassessment

Sts. Peter and Paul
49 Fennell Avenue East,
Hamilton, Ontario

August 30, 2022

Pinchin File: 303992.004

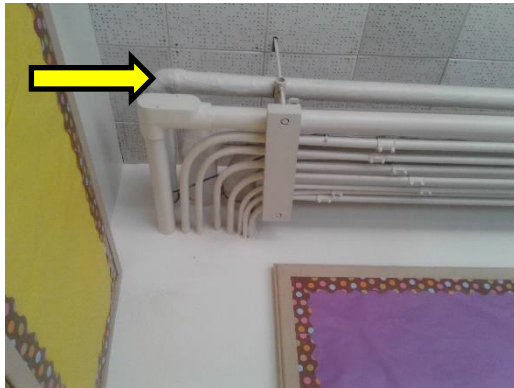
Material and Application	Asbestos Type/Friability	Photo
Parging cement is present on pipe fittings (elbows, valves, tees, hangers etc.)	Chrysotile/Friable

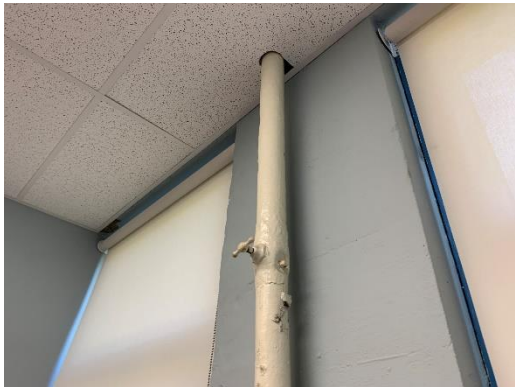
Material and Application	Asbestos Type/Friability	Photo
Sweatwrap insulation (brown layered paper) is present on straight sections of pipes.	None

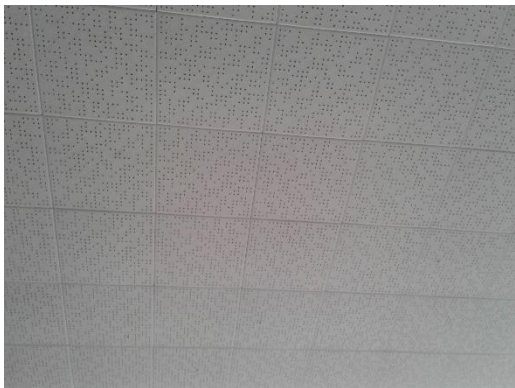
Remaining pipes are either uninsulated or insulated with non-asbestos fibreglass or elastomeric insulation (Armaflex).	None	
Ducts are either uninsulated or insulated with non-asbestos fibreglass (foil-faced or canvas).	None	
Mechanical equipment is either uninsulated or insulated with non-asbestos fibreglass.	None	
Vermiculite is present as insulation in perimeter masonry block walls of the Gymnasium (Location 1001). The vermiculite was analyzed and no asbestos was detected.	None	
12"x12" glued-on ceiling tiles, with a pinhole pattern are present. Non-asbestos adhesive is present on the backside on the glued-on ceiling tiles.	None (tile) None (adhesive)

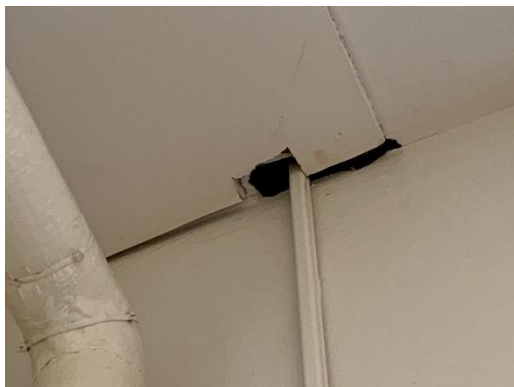
Material and Application	Asbestos Type/Friability	Photo
All lay-in ceiling tiles were determined to be non-asbestos based on previous sampling or are presumed to be non-asbestos based on the date of manufacture determined from the date stamp applied to the top of the tiles or the age of the materials determined from the age of the building or the renovation.	None	
Smooth and rough plaster present on walls and ceilings does not contain asbestos.	None	
Asbestos-containing drywall joint compound is present as a patch material on plaster in Classroom (Location 2005) and may be present in other locations.	Chrysotile/Non-friable

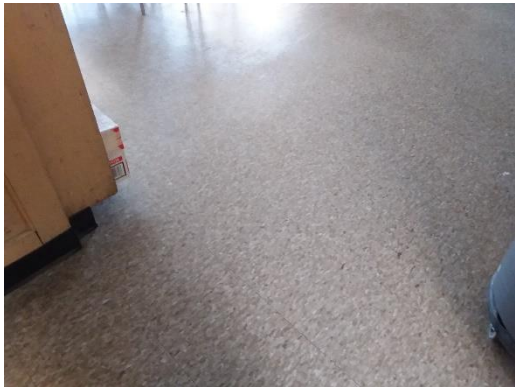
Material and Application	Asbestos Type/Friability	Photo
<p>Vinyl sheet flooring, with a brown pebble pattern is present.</p> <p>The adhesive adhered to the vinyl sheet flooring backing contains asbestos.</p>	<p>Chrysotile/Potentially Friable (sheet flooring)</p> <p>Chrysotile/Non-friable (mastic)</p>

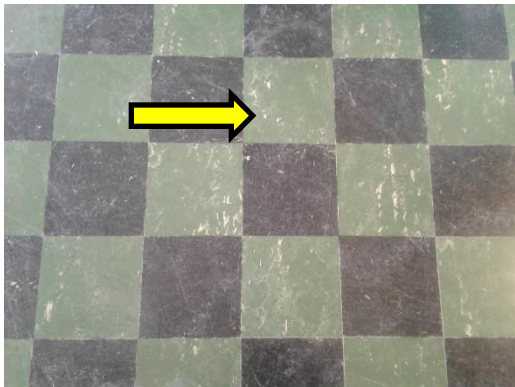
<p>Vinyl floor tiles, 9"x9", green with white marble, are present.</p>	<p>Chrysotile/Non-friable (tile)</p> <p>Chrysotile/Non-friable (mastic)</p>

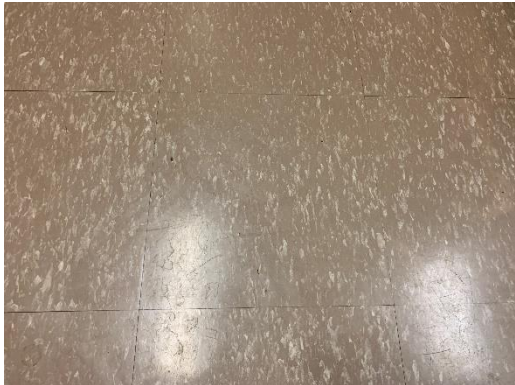
<p>Vinyl floor tiles, 9"x9", green with white streaks, are present.</p>	<p>Chrysotile/Non-friable (tile)</p> <p>Chrysotile/Non-friable (mastic)</p>

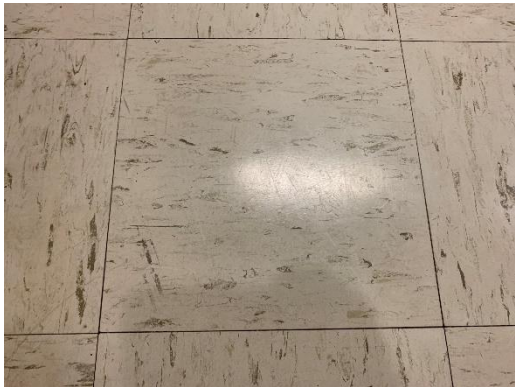
Material and Application	Asbestos Type/Friability	Photo
Vinyl floor tiles, 9"x9", light green with green streaks, are present.	Chrysotile/Non-friable (tile) Chrysotile/Non-friable (mastic)

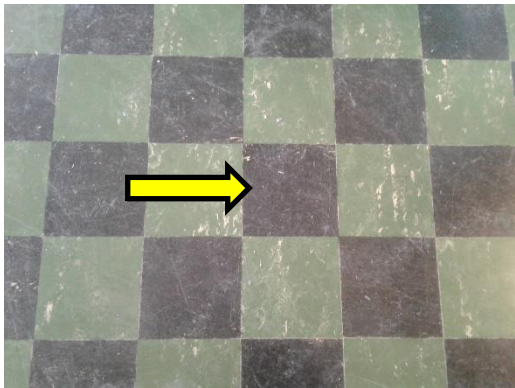
Vinyl floor tiles, 9"x9", black and white marble, are present.	Chrysotile/Non-friable (tile) Chrysotile/Non-friable (mastic)	<div>w</div>

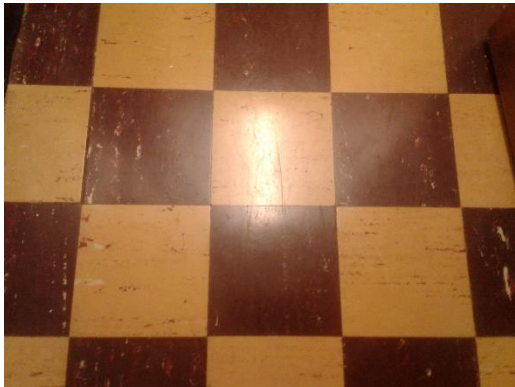
Vinyl floor tiles, 9"x9", burgundy/orange, are present.	Presumed/Non-friable (tile) Presumed/Non-friable (mastic)

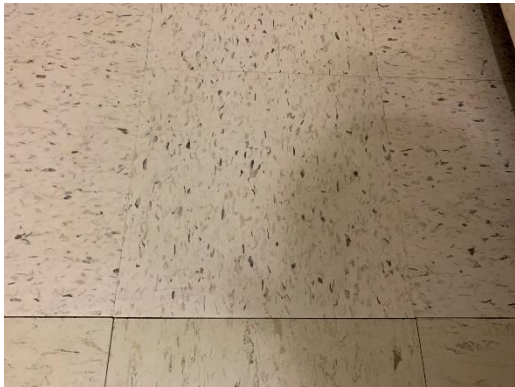
Material and Application	Asbestos Type/Friability	Photo
Vinyl floor tiles, 12"x12", white with black speck, are present.	Chrysotile/Non-friable (tile) Chrysotile/Non-friable (mastic)

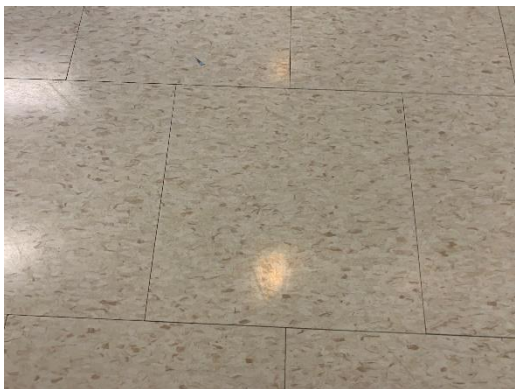
Vinyl floor tiles, 12"x12" pink with dark pink streaks, are present.	Presumed/Non-friable (tile) Presumed/Non-friable (mastic)

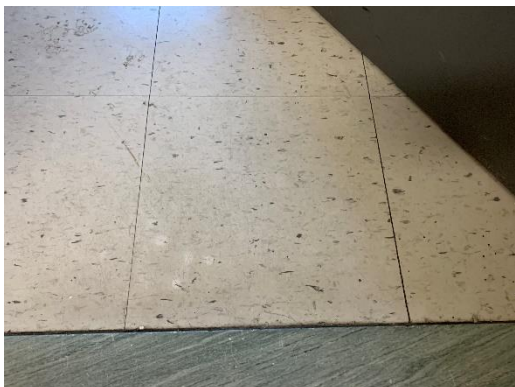
Vinyl floor tiles, 12"x12" white with black, are present.	Presumed/Non-friable (tile) Presumed/Non-friable (mastic)

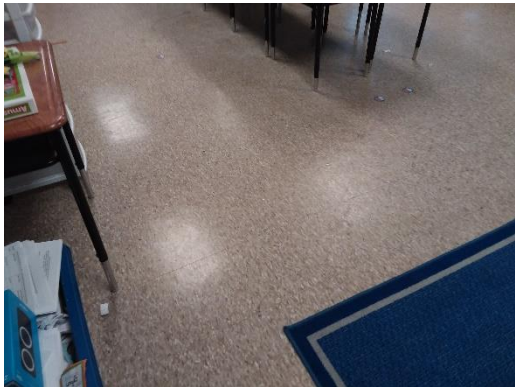
Material and Application	Asbestos Type/Friability	Photo
Vinyl floor tiles, 12"x12" pink marble, are present.	Presumed/Non-friable (tile) Presumed/Non-friable (mastic)

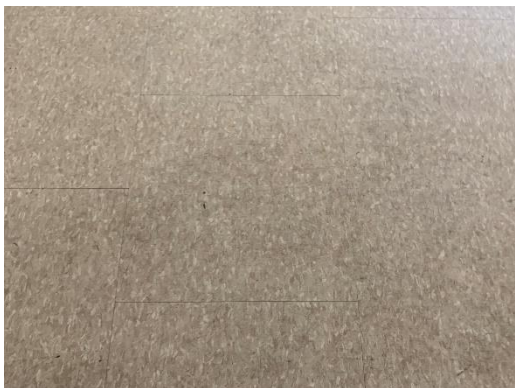
Vinyl floor tiles, 12"x12" grey with light grey fleck, are present.	Presumed/Non-friable (tile) Presumed/Non-friable (mastic)

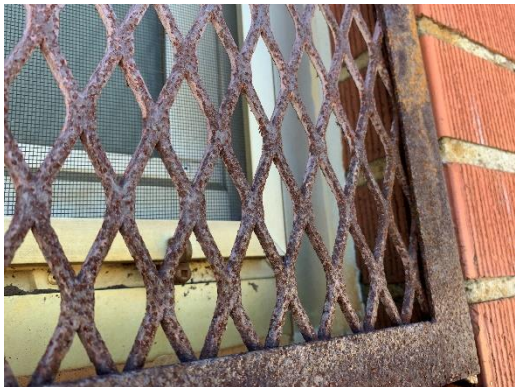
Material and Application	Asbestos Type/Friability	Photo
<p>Remaining vinyl floor tiles were presumed to be non-asbestos based on historical knowledge of the date of installation.</p> <p>Mastic underneath new flooring within the original building is presumed to contain asbestos until further sampling proves otherwise.</p>	<p>None (tile)</p> <p>Presumed/Non-friable (mastic)</p>	
<p>Grey caulking is present around windows.</p>	<p>Chrysotile/Non-friable</p>
