Asbestos Reassessment

Thomas J Mahony
57 Stuart Street, Hamilton,
Ontario

**Hamilton-Wentworth Catholic
District School Board**

August 26, 2022

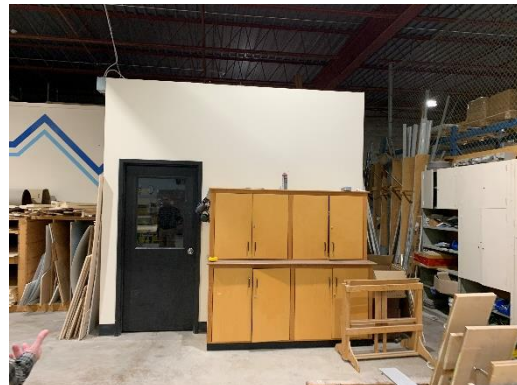
Material and Application	Asbestos Type/Friability	Photo
Drywall joint compound is present on wall and ceiling finishes.	Chrysotile/Non-friable

Asbestos in drywall joint compound was banned in Canada in 1980. Drywall joint compound in the 2012 and 2018 renovation areas was installed after 1986 (1980 plus a reasonable non-compliance period based on our experience) and is assumed to contain no asbestos.	None	
All vinyl floor tiles and mastic are presumed to be non-asbestos based on historical knowledge of the date of installation.	None (tile) None (mastic)
