Asbestos Reassessment

Nicolas Mancini Centre
44 Hunt Street, Hamilton,
Ontario

**Hamilton-Wentworth Catholic
District School Board**

August 26, 2022

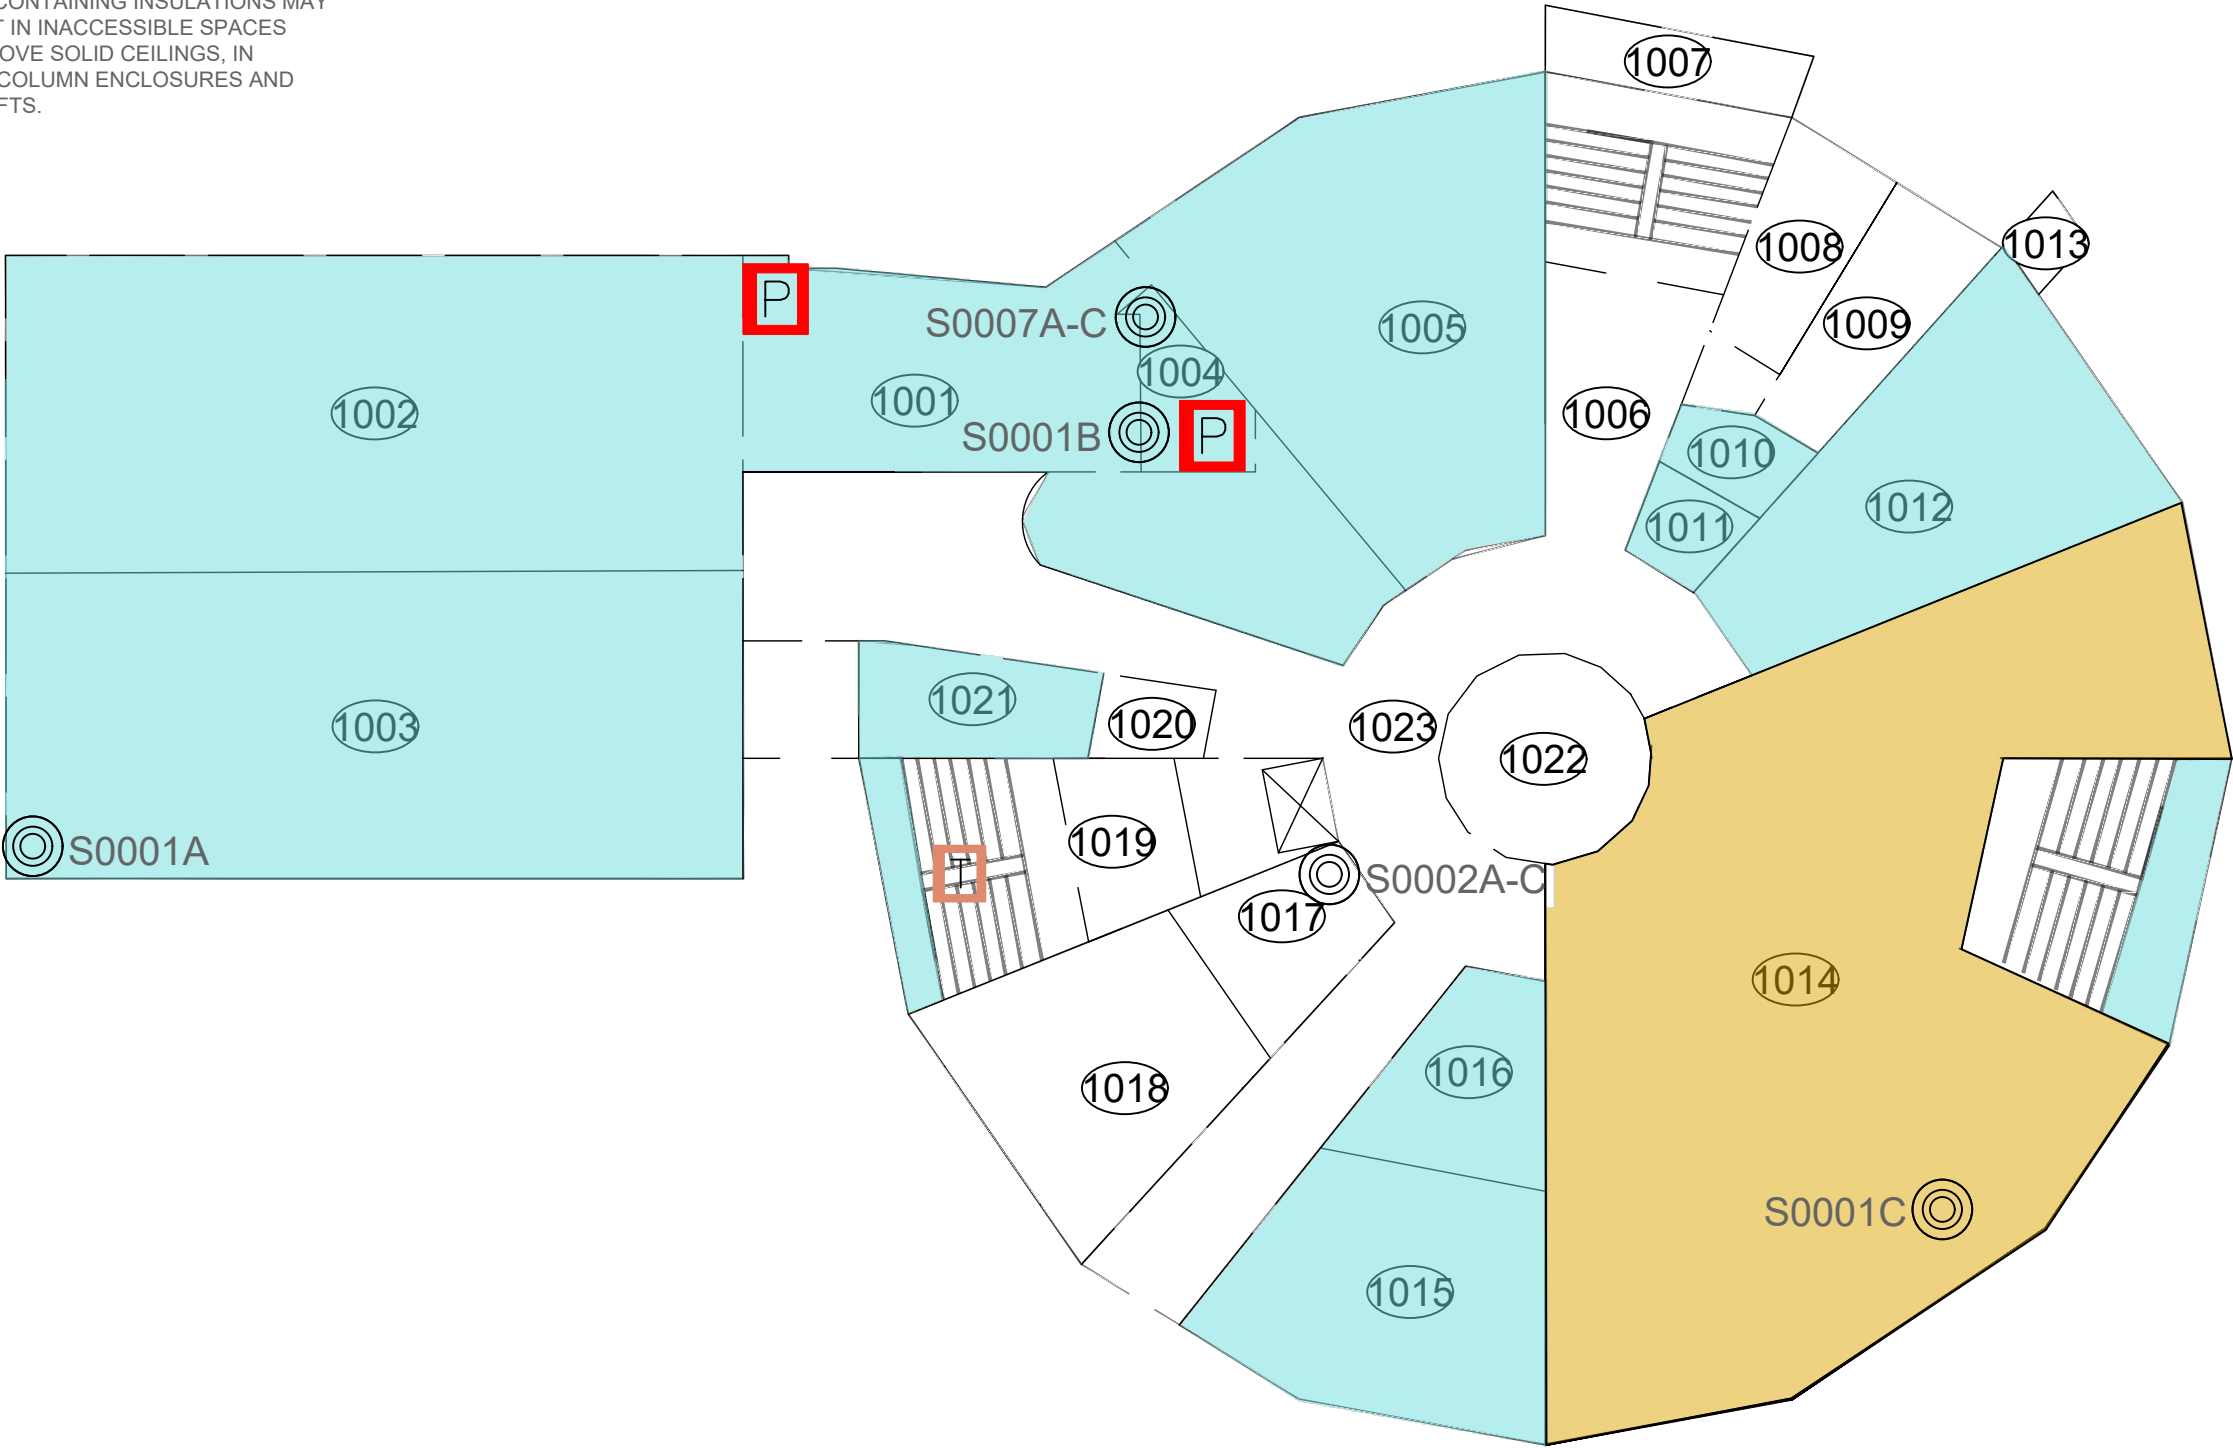
TITLE:
ASBESTOS REASSESSMENT
FLOOR LEVEL 1

PIPES INSULATED WITH ASBESTOS-CONTAINING INSULATIONS MAY BE PRESENT IN INACCESSIBLE SPACES SUCH AS ABOVE SOLID CEILINGS, IN CHASES, IN COLUMN ENCLOSURES AND WITHIN SHAFTS.

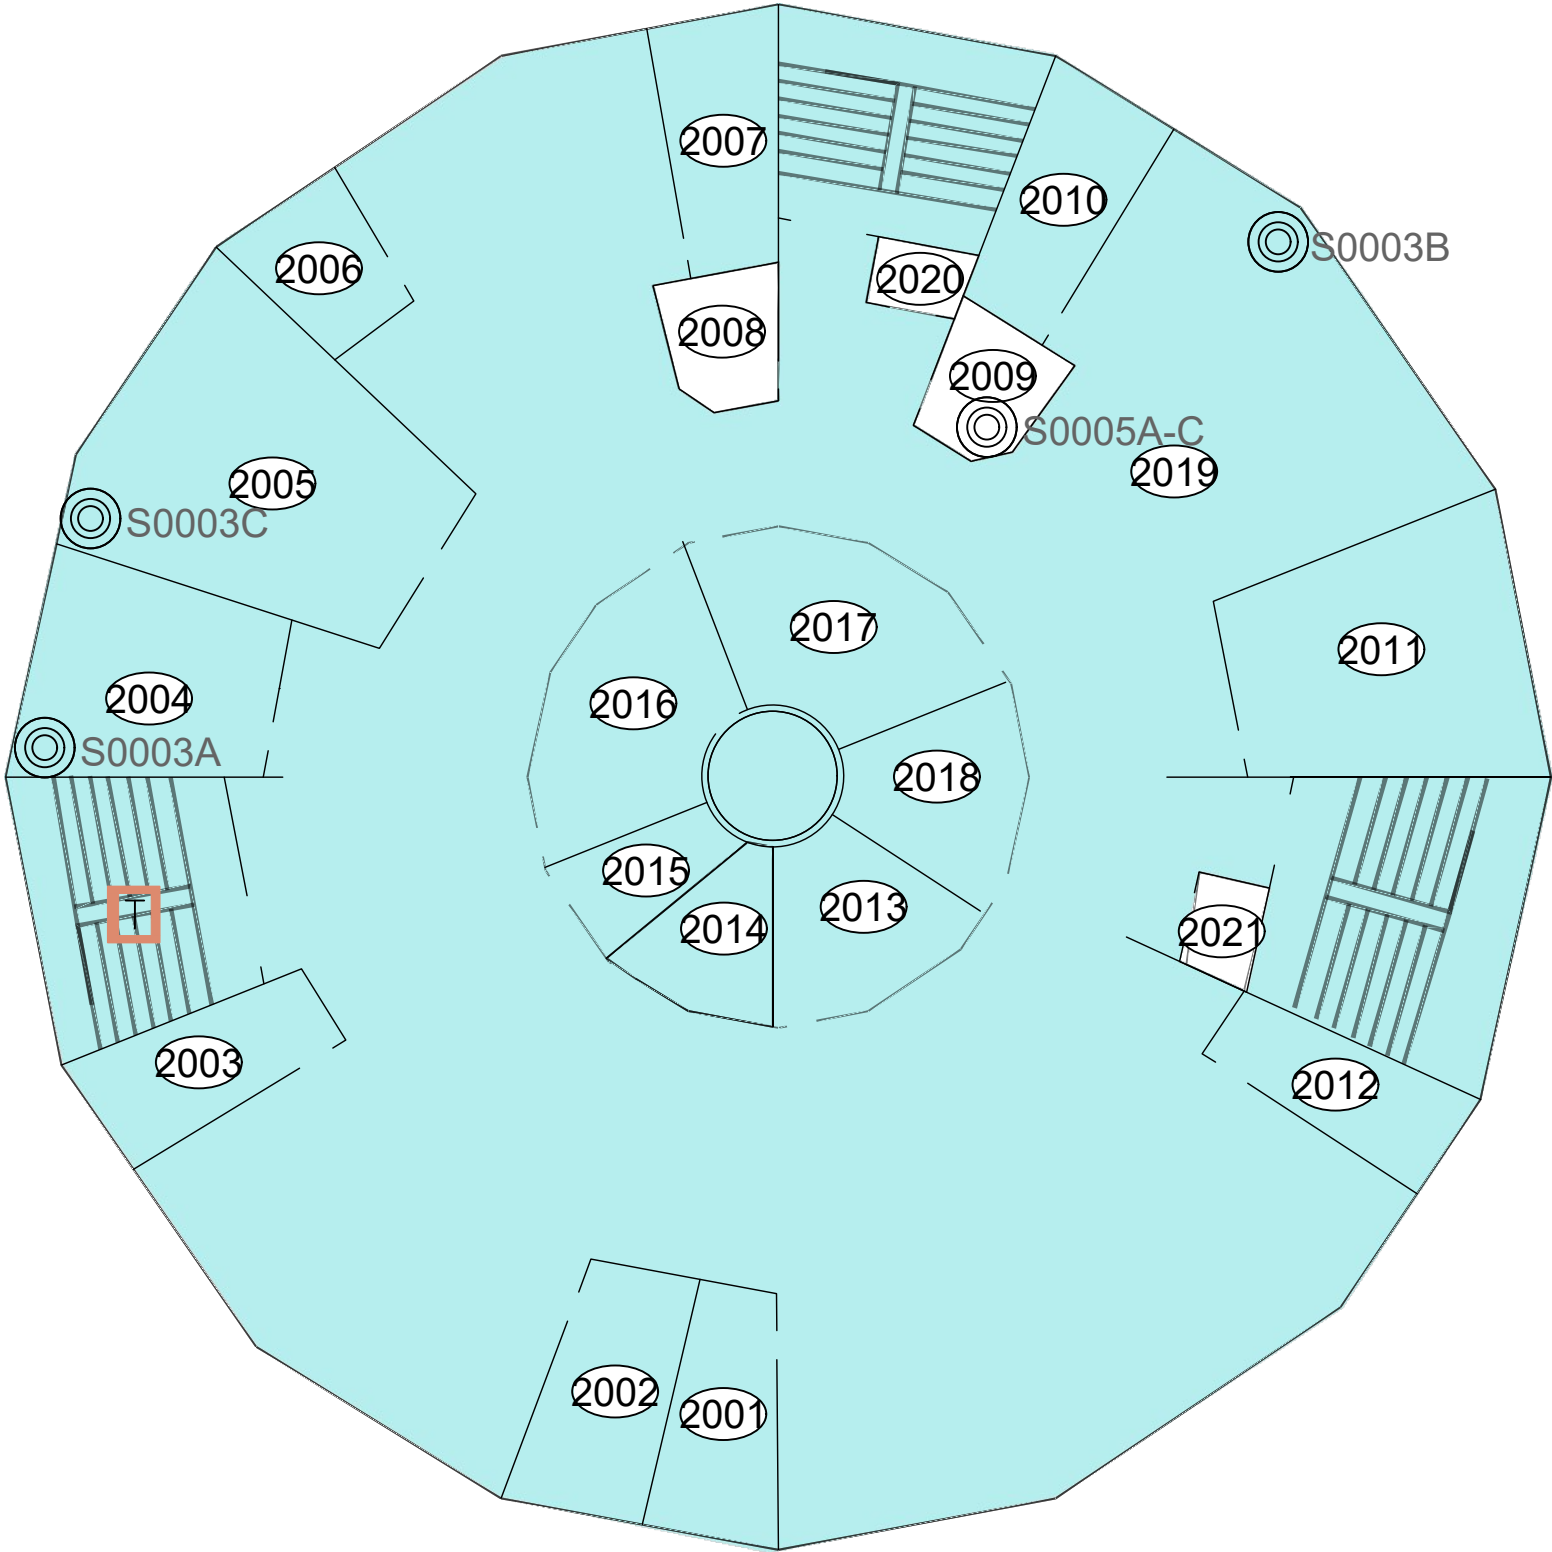
TITLE:
ASBESTOS REASSESSMENT
FLOOR LEVEL 2

PIPES INSULATED WITH ASBESTOS-CONTAINING INSULATIONS MAY BE PRESENT IN INACCESSIBLE SPACES SUCH AS ABOVE SOLID CEILINGS, IN CHASES, IN COLUMN ENCLOSURES AND WITHIN SHAFTS.
