Asbestos Reassessment

St. Charles Mountain
150 East 5th Street, Hamilton,
Ontario

August 30, 2022

Pinchin File: 303992.004

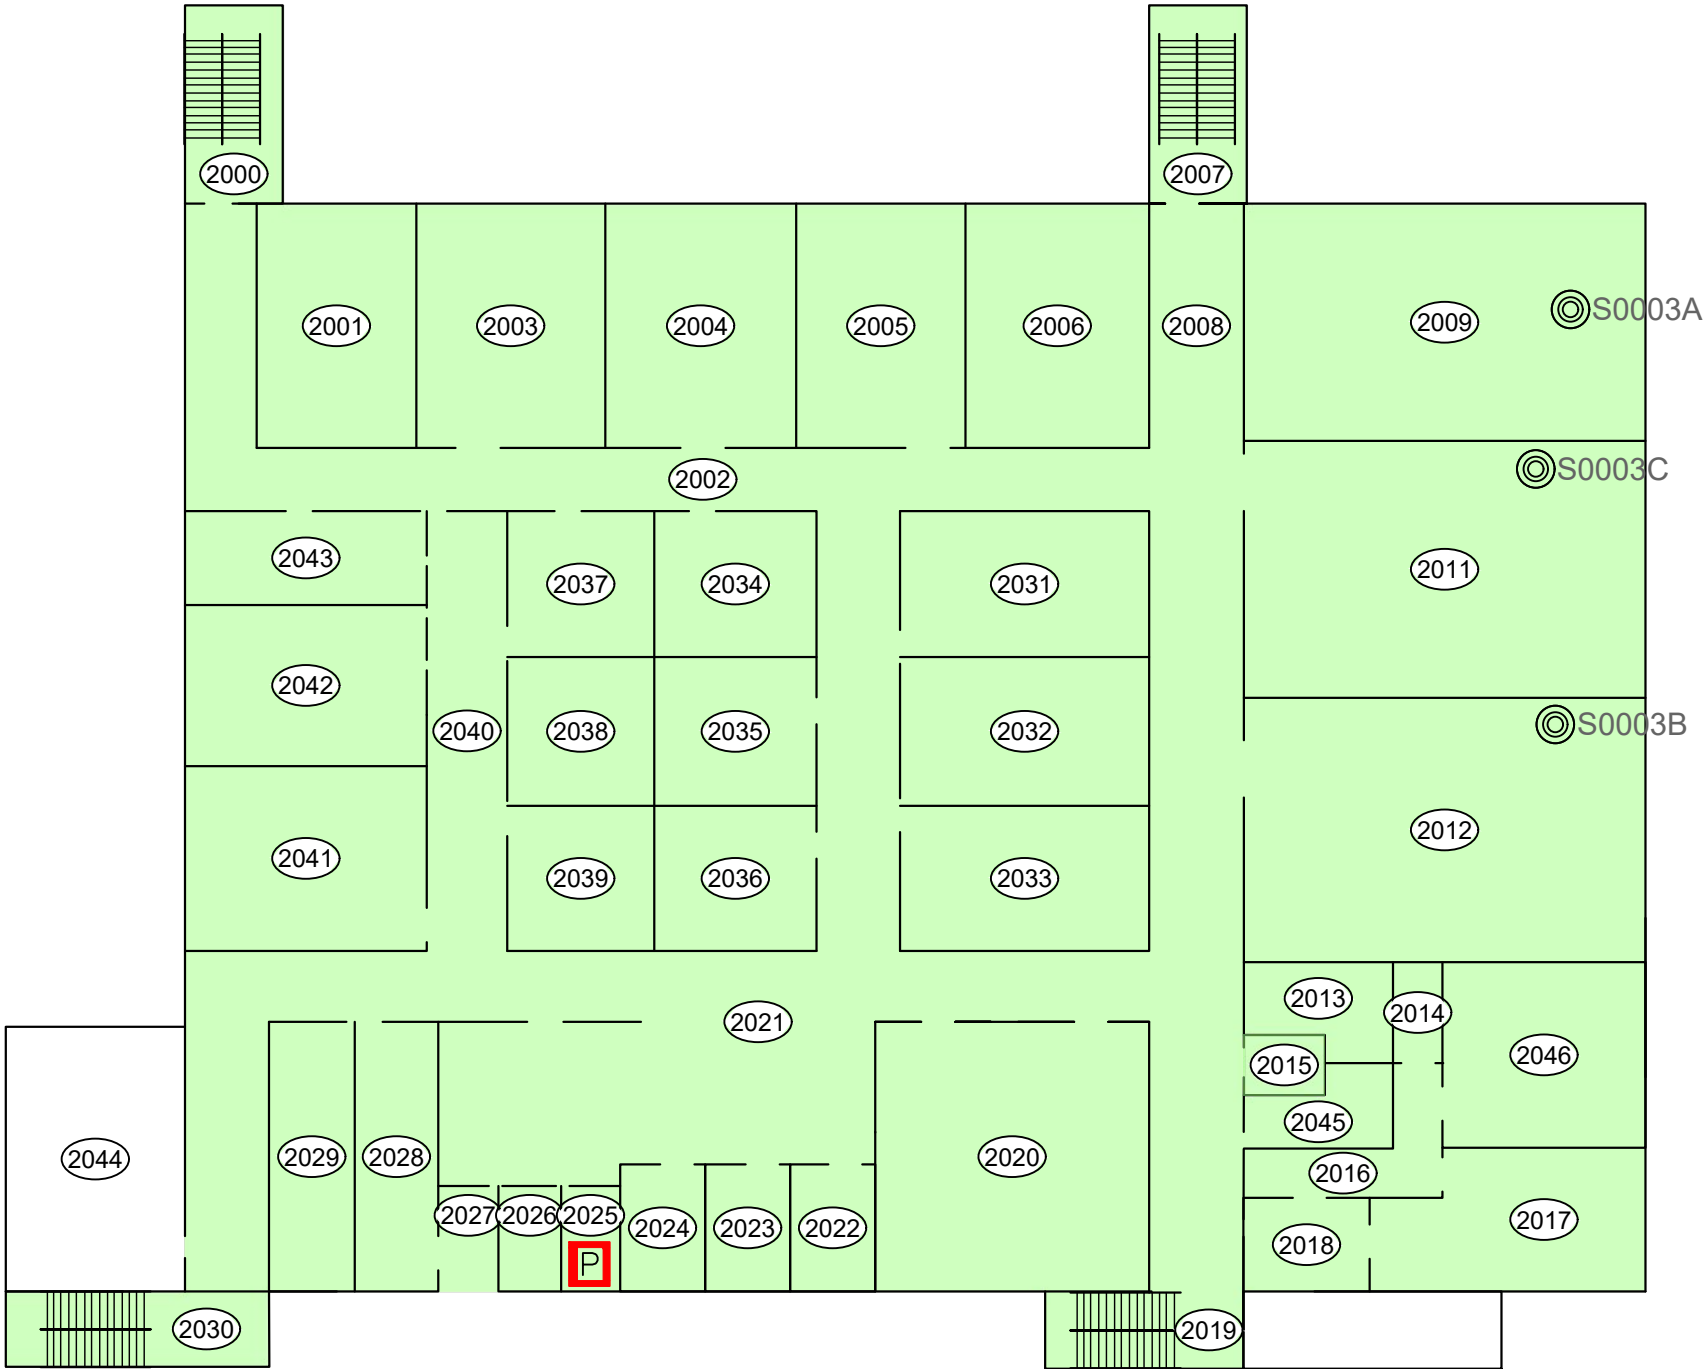
TITLE:
ASBESTOS REASSESSMENT
FLOOR LEVEL 2

ASBESTOS-CONTAINING DRYWALL JOINT COMPOUND IS PRESENT ON WALL AND CEILING FINISHES THROUGHOUT THE BUILDING.

ASBESTOS-CONTAINING MATERIALS NOT HATCHED:
- DRYWALL JOINT COMPOUND ON WALLS AND CEILING
- WINDOW PUTTY SEALANT
