Asbestos Reassessment

St. Patrick
24 Smith Avenue, Hamilton,
Ontario

Pinchin File: 303992.004

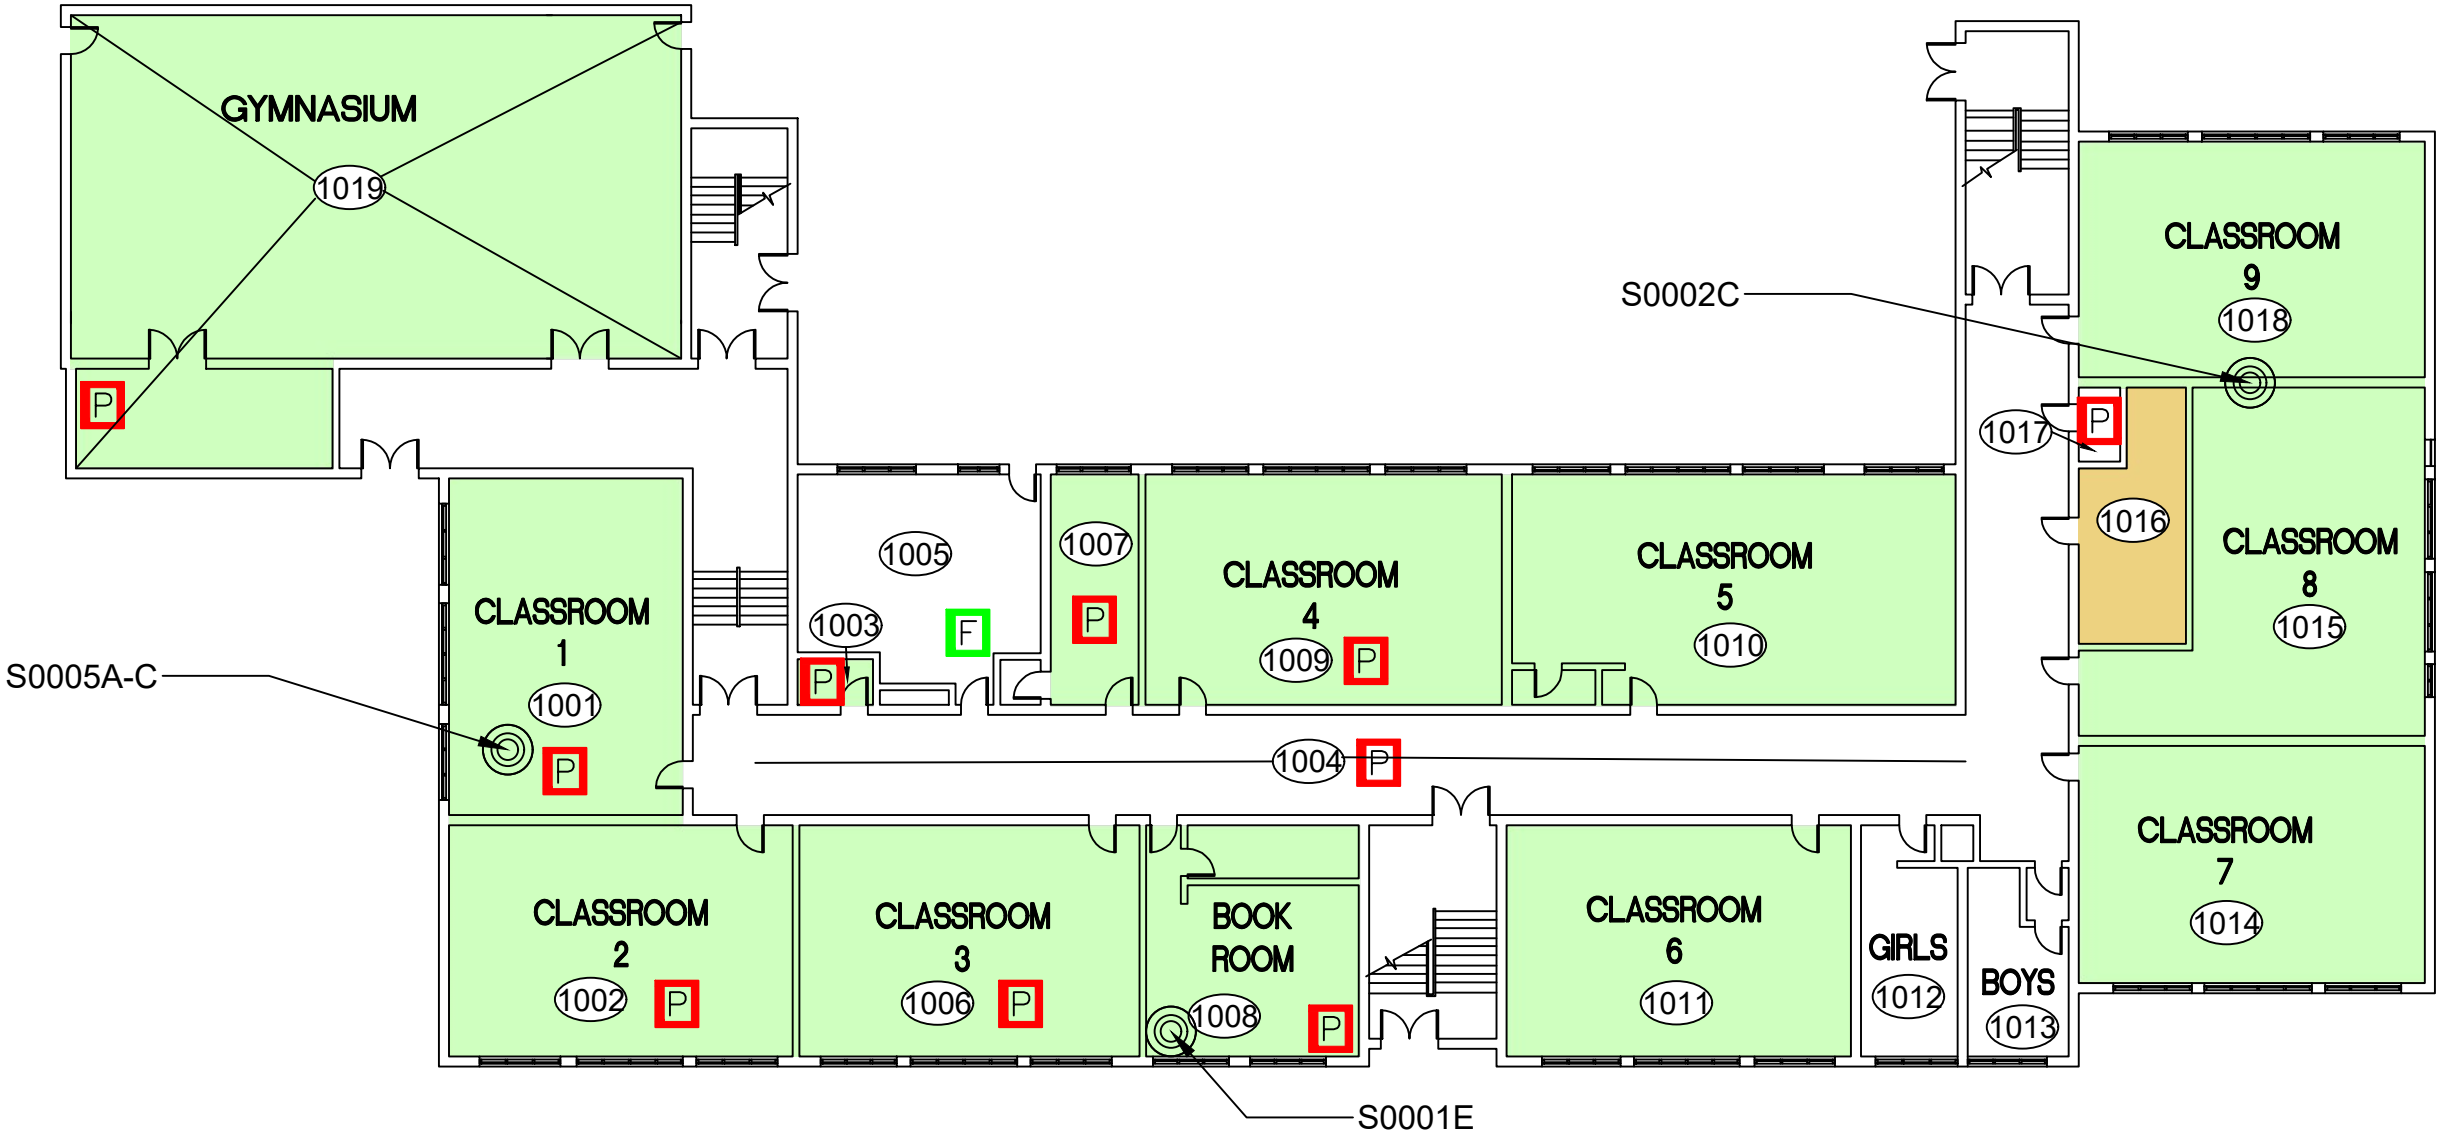
1 OF 3

ASBESTOS-CONTAINING GLAZING PUTTY IS PRESENT BETWEEN GLASS AND FRAMES ON EXTERIOR WINDOWS THROUGHOUT THE BUILDING.
