Asbestos Reassessment

St. Agnes
80 Colcrest Street, Hamilton,
Ontario

**Hamilton-Wentworth Catholic
District School Board**

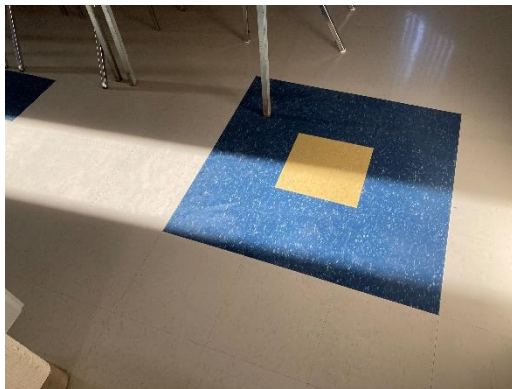
Material and Application	Asbestos Type/Friability	Photo
(foam) or based on the lack of a paper backing layer (underpad).		
Vinyl floor tiles were presumed to be non-asbestos based on historical knowledge of the date of installation (2005). The mastic below the tiles is presumed to contain asbestos.	None (tile) Presumed/Non-friable (mastic)
